Access Compliance Report

Public Rights-of-Way

(Curb Ramps)

Intersection ID: N/A	Main Street: NEW_FASHION_WY	Cross Street: OUTLETS_BV	Location:	N
ADA ID: A4F81970B8B2	Ramp Type: Perp	Initial Pass/Fail: Fail	Overall Compliance: No	Severity Score: 12.5
Codes/Mitigation Info/Possible Solution		Field Measurements/Component Compliance

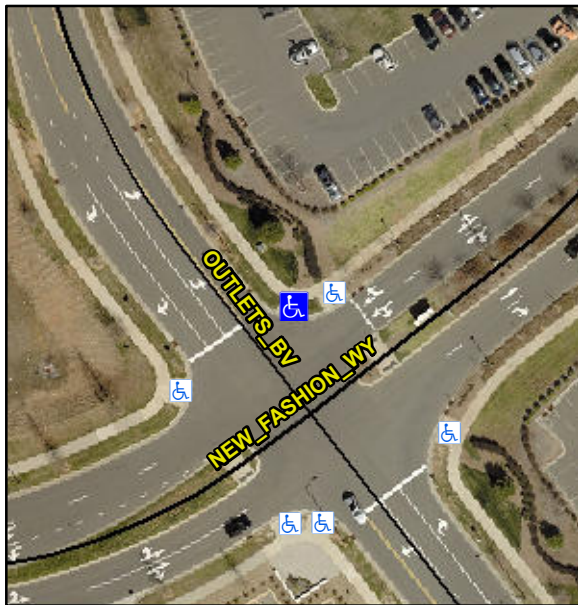
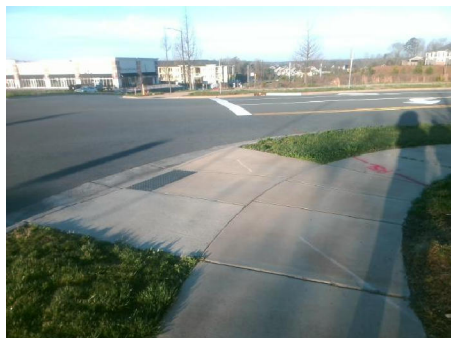
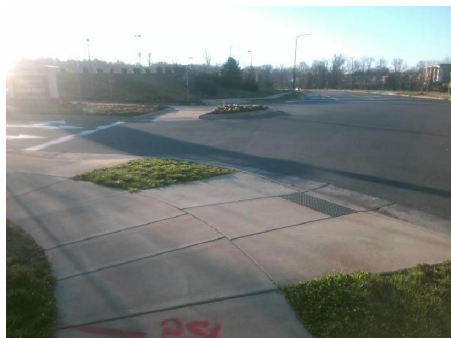
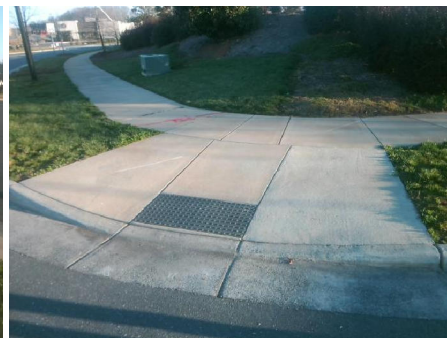
Not Found, R304.2.2

Compliance	Description	Data	Compliance	Description	Data
N/A	Ramp Length (in)	96.0	No	Ramp Slope (%)	8.5
Yes	Ramp Width (in)	48.0	Yes	Ramp XSlope (%)	1.0
N/A	Flare Type LT	N/A	N/A	Flare Type RT	N/A
N/A	Flare Slope LT (%)	N/A	N/A	Flare Slope RT (%)	N/A
N/A	Flare Traversable LT?	N/A	N/A	Flare Traversable RT?	N/A
N/A	Landing Length (in)	N/A	N/A	DWS Provided?	N/A
N/A	Landing Width (in)	N/A	N/A	DWS Contrast?	N/A
N/A	Landing Slope (%)	N/A	N/A	DWS Length (in)	N/A
N/A	Landing X Slope (%)	N/A	N/A	DWS Full Width?	N/A
N/A	Landing Curb? (Y/N)	N/A	N/A	DWS Offset (in)	N/A
N/A	Shared Landing?	N/A			
N/A	Gutter Ponding?	N/A	N/A	Gutter Slope (%)	N/A
N/A	Gutter Lip Ht (in)	N/A	N/A	Gutter X Slope (%)	N/A
N/A	Painted X Walk1?	No	N/A	Painted X Walk2?	N/A
	X Walk 1 Direction	To SW		X Walk 2 Direction	N/A
N/A	X Walk 1 Width (in)	N/A	N/A	X Walk 2 Width (in)	N/A
	X Walk 1 Slope (%)	2.3		X Walk 2 Slope (%)	N/A
	X Walk 1 X Slope (%)	1.8		X Walk 2 X Slope (%)	N/A

N/A	Ramp inside XWalk1?	N/A	N/A	Ramp inside XWalk2?	N/A
	Road Slope (%)	N/A	N/A	Clear Space?	N/A
	Road X Slope (%)	N/A	N/A	Clear Space to XWalk (in)	N/A
N/A	Any Obstructions?	N/A	N/A	Storm Grate/Utility Hazard?	N/A
	Obstruction Type			Storm Grate/Utility Type	
		N/A			N/A
			Yes	Surface Condition? (G/P)	Good

Possible Solutions:

Remove & Replace Entire Ramp.
