# Access Compliance Report

## Public Rights-of-Way

### (Curb Ramps)

Intersection ID: 49278	Main Street: HAMILTON_RD	Cross Street: REUNION_ST	Location: NW
ADA ID: A5043805AF84	Ramp Type: ParaDiag	Initial Pass/Fail: Fail	Overall Compliance: No
		Severity Score: 12.5

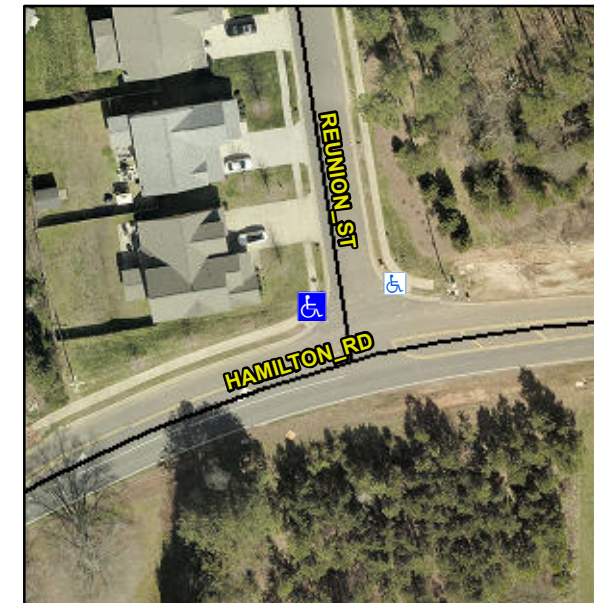
**RT RP < 5%**

**R304.3.2**

Compliance	Description	Data	Compliance	Description	Data
N/A	Ramp Length LT (in)	61.0	N/A	Ramp Length RT (in)	52.0
Yes	Ramp Width LT (in)	99.0	Yes	Ramp Width RT (in)	95.0
No	Ramp Slope LT (%)	11.1	Yes	Ramp Slope RT (%)	1.2
Yes	Ramp XSlope LT (%)	0.4	Yes	Ramp XSlope RT (%)	1.4
N/A	Landing Length (in)	N/A	N/A	DWS Provided?	N/A
N/A	Landing Width (in)	N/A	N/A	DWS Contrast?	N/A
N/A	Landing Slope (%)	N/A	N/A	DWS Length (in)	N/A
N/A	Landing X Slope (%)	N/A	N/A	DWS Full Width?	N/A
N/A	Landing Curb? (Y/N)	N/A	N/A	DWS Offset (in)	N/A
N/A	Shared Landing?	N/A			
N/A	Gutter Ponding?	N/A	N/A	Gutter Slope (%)	N/A
N/A	Gutter Lip Ht (in)	N/A	N/A	Gutter X Slope (%)	N/A
N/A	Painted X Walk1?	No	N/A	Painted X Walk2?	No
	X Walk 1 Direction	To S		X Walk 2 Direction	To E
N/A	X Walk 1 Width (in)	N/A	N/A	X Walk 2 Width (in)	N/A
	X Walk 1 Slope (%)	6.8		X Walk 2 Slope (%)	2.3
	X Walk 1 X Slope (%)	2.1		X Walk 2 X Slope (%)	4.7
N/A	Ramp inside XWalk1?	N/A	N/A	Ramp inside XWalk2?	N/A

Road Slope (%)	4.4	N/A	Clear Space?	N/A
	Road X Slope (%)	6.5	N/A	Clear Space to XWalk (in)	N/A
N/A	Any Obstructions?	N/A	N/A	Storm Grate/Utility Hazard?	N/A
	Obstruction Type			Storm Grate/Utility Type	
		N/A			N/A
			Yes	Surface Condition? (G/P)	Good
			N/A	Curb Slope (%)	6.6

**Remove & Replace Curb Ramp With Two New Directional Ramps or Equivalent.**
