Access Compliance Report

Public Rights-of-Way (Curb Ramps)

Intersection ID: 5272	Main Street: CHINEMIST_CT	Cross Street: FROSTMOR_PL	Location: NE
ADA ID: A505ED10FA1C	Ramp Type: Directional1	Initial Pass/Fail: Fail	Overall Compliance: No
Severity Score: 48.75			
Codes/Mitigation Info/Possible Solution		Field Measurements/Component Compliance

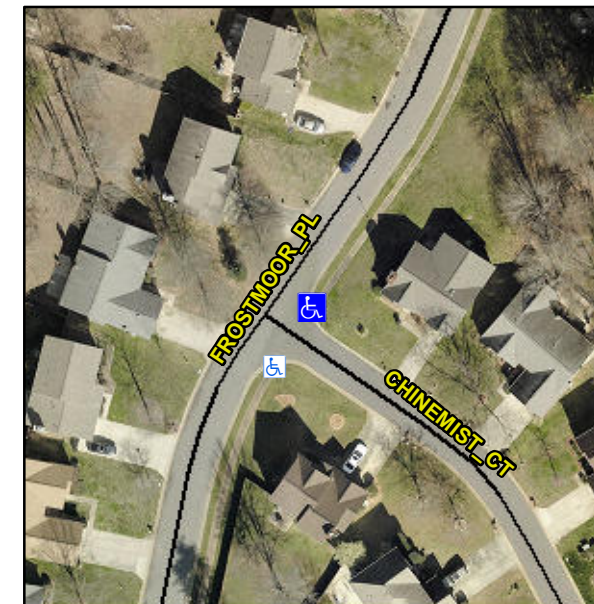
Compliance	Description	Data	Compliance	Description	Data
N/A	Ramp Length (in)	26.0	N/A	Grade Break?	N/A
No	Ramp Width (in)	43.0	N/A	Grade Break Slope (%)	0.0
No	Ramp Slope (%)	20.0	N/A	Grade Break XSlope (%)	0.0
Yes	Ramp XSlope (%)	0.6			
N/A	Flare Type LT	N/A	N/A	Flare Type RT	N/A
N/A	Flare Slope LT (%)	N/A	N/A	Flare Slope RT (%)	0.0
N/A	Flare Traversable LT?	N/A	N/A	Flare Traversable RT?	N/A
N/A	Landing Length (in)	0.0	N/A	DWS Provided?	N/A
N/A	Landing Width (in)	0.0	N/A	DWS Contrast?	N/A
N/A	Landing Slope (%)	0.0	N/A	DWS Length (in)	N/A
N/A	Landing X Slope (%)	0.0	N/A	DWS Full Width?	N/A
N/A	Landing Curb? (Y/N)	N/A	N/A	DWS Offset LT (in)	N/A
N/A	Shared Landing?	N/A	N/A	DWS Offset RT (in)	N/A
N/A	Gutter Ponding?	0.0	N/A	Gutter Slope (%)	N/A
N/A	Gutter Lip Ht (in)	0.0	N/A	Gutter X Slope (%)	N/A
N/A	Painted X Walk1?	No		Road Slope (%)	7.1
	X Walk 1 Direction	To W		Road X Slope (%)	0.2
	X Walk 1 Width (in)	N/A		Clear Space?	N/A

X Walk 1 Slope (%)	7.1	N/A	Clear Space to XWalk (in)	N/A
	X Walk 1 X Slope (%)	0.2	N/A	Storm Grate/Utility Hazard?	N/A
N/A	Ramp inside XWalk1?	N/A		Storm Grate/Utility Type	
N/A	Any Obstructions?	N/A			N/A
	Obstruction Type		No	Surface Condition? (G/P)	Poor
			N/A	Curb Slope (%)	7.8

Remove & Replace Entire Ramp.

R304.5.1, R304.2.2, R302.7
