Access Compliance Report

Public Rights-of-Way

(Curb Ramps)

Intersection ID: 10038783	Main Street: STEELE_CREEK_RD	Cross Street: N/A	Location: NW
ADA ID: A50E593A4C1A	Ramp Type: Combination1Diag	Initial Pass/Fail: Fail	Overall Compliance: No
		Severity Score: 0

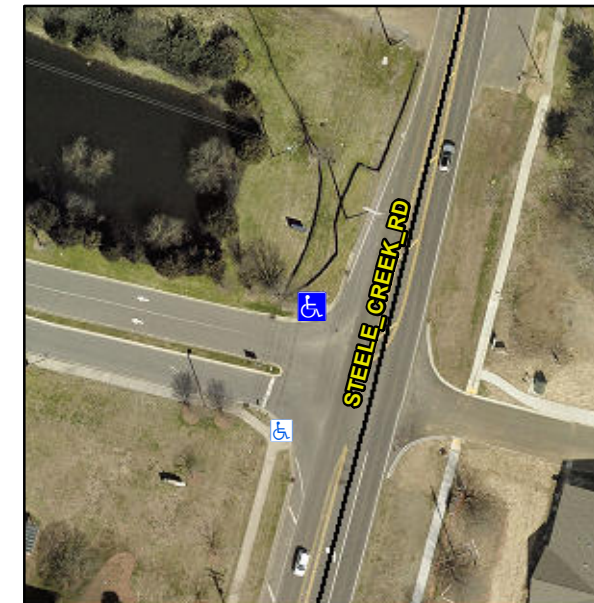
RT RP < 5%

R304.5.3, R304.3.2

Compliance	Description	Data	Compliance	Description	Data
N/A	Ramp Length LT (in)	56.0	N/A	Ramp Length RT (in)	42.0
Yes	Ramp Width LT (in)	59.0	Yes	Ramp Width RT (in)	60.0
No	Ramp Slope LT (%)	11.3	Yes	Ramp Slope RT (%)	3.2
Yes	Ramp XSlope LT (%)	0.6	No	Ramp XSlope RT (%)	5.5
N/A	Ramp Length (in)	35.0	Yes	Ramp Slope (%)	5.7
Yes	Ramp Width (in)	51.0	No	Ramp XSlope (%)	5.6
N/A	Flare Type LT	N/A	N/A	Flare Type RT	N/A
N/A	Flare Slope LT (%)	N/A	N/A	Flare Slope RT (%)	N/A
N/A	Flare Traversable LT?	N/A	N/A	Flare Traversable RT?	N/A
N/A	Landing Length (in)	N/A	N/A	DWS Provided?	N/A
N/A	Landing Width (in)	N/A	N/A	DWS Contrast?	N/A
N/A	Landing Slope (%)	N/A	N/A	DWS Length (in)	N/A
N/A	Landing X Slope (%)	N/A	N/A	DWS Full Width?	N/A
N/A	Landing Curb? (Y/N)	N/A	N/A	DWS Offset (in)	N/A
N/A	Shared Landing?	N/A			
N/A	Gutter Ponding?	N/A	N/A	Gutter Slope (%)	N/A
N/A	Gutter Lip Ht (in)	N/A	N/A	Gutter X Slope (%)	N/A
N/A	Painted X Walk1?	No	N/A	Painted X Walk2?	No

X Walk 1 Direction	To S		X Walk 2 Direction	To E
	X Walk 1 Width (in)	N/A		X Walk 2 Width (in)	N/A
	X Walk 1 Slope (%)	3.0		X Walk 2 Slope (%)	3.0
	X Walk 1 X Slope (%)	5.9		X Walk 2 X Slope (%)	1.1
N/A	Ramp inside XWalk1?	N/A	N/A	Ramp inside XWalk2?	N/A
	Road Slope (%)	3.8		Clear Space?	N/A
	Road X Slope (%)	1.6	N/A	Clear Space to XWalk (in)	N/A
			N/A	Any Obstruction?	N/A
				Obstruction Type	N/A
			N/A	Storm Grate/Utility Hazard?	N/A
				Storm Grate/Utility Type	N/A
Yes	Surface Condition? (G/P)	Good			
	Curb Slope (%)	3.3

Remove & Replace Curb Ramp With Two New Directional Ramps or Equivalent.
