Access Compliance Report

Public Rights-of-Way

(Curb Ramps)

Intersection ID: 10036656	Main Street: S_CALDWELL_ST	Cross Street: N/A	Location: SE
ADA ID: A50F931FBC57	Ramp Type: Directional1	Initial Pass/Fail: Fail	Overall Compliance: No
Codes/Mitigation Info/Possible Solution		Field Measurements/Component Compliance	
Severity Score: 13.75

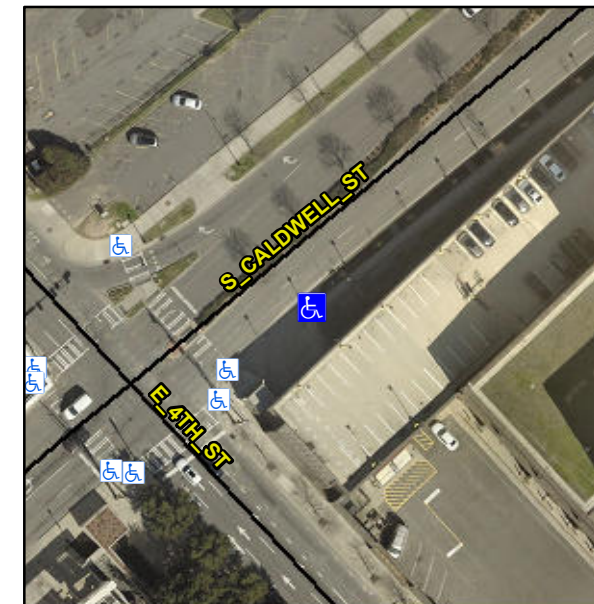
CURB LIP 1.0"

R304.2.2, R304.5.3

Compliance	Description	Data	Compliance	Description	Data
N/A	Ramp Length (in)	39.0	N/A	Grade Break?	N/A
Yes	Ramp Width (in)	55.5	N/A	Grade Break Slope (%)	0.0
No	Ramp Slope (%)	11.2	N/A	Grade Break XSlope (%)	0.0
No	Ramp XSlope (%)	3.7			
N/A	Flare Type LT	N/A	N/A	Flare Type RT	N/A
N/A	Flare Slope LT (%)	N/A	N/A	Flare Slope RT (%)	0.0
N/A	Flare Traversable LT?	N/A	N/A	Flare Traversable RT?	N/A
N/A	Landing Length (in)	0.0	N/A	DWS Provided?	N/A
N/A	Landing Width (in)	0.0	N/A	DWS Contrast?	N/A
N/A	Landing Slope (%)	0.0	N/A	DWS Length (in)	N/A
N/A	Landing X Slope (%)	0.0	N/A	DWS Full Width?	N/A
N/A	Landing Curb? (Y/N)	N/A	N/A	DWS Offset LT (in)	N/A
N/A	Shared Landing?	N/A	N/A	DWS Offset RT (in)	N/A
N/A	Gutter Ponding?	0.0	N/A	Gutter Slope (%)	N/A
N/A	Gutter Lip Ht (in)	0.0	N/A	Gutter X Slope (%)	N/A
N/A	Painted X Walk1?	No		Road Slope (%)	4.2
	X Walk 1 Direction	To SW		Road X Slope (%)	0.4
	X Walk 1 Width (in)	N/A		Clear Space?	N/A

Remove & Replace Entire Ramp.
