Access Compliance Report

Public Rights-of-Way

(Curb Ramps)

Intersection ID: 29915	Main Street: NORTHRIDGE_DR	Cross Street: WYNDHAM_HILL_DR	Location: SE
ADA ID: A51E2B77970A	Ramp Type: PerpDiag	Initial Pass/Fail: Fail	Overall Compliance: No
Severity Score: 46.25			
Codes/Mitigation Info/Possible Solution		Field Measurements/Component Compliance

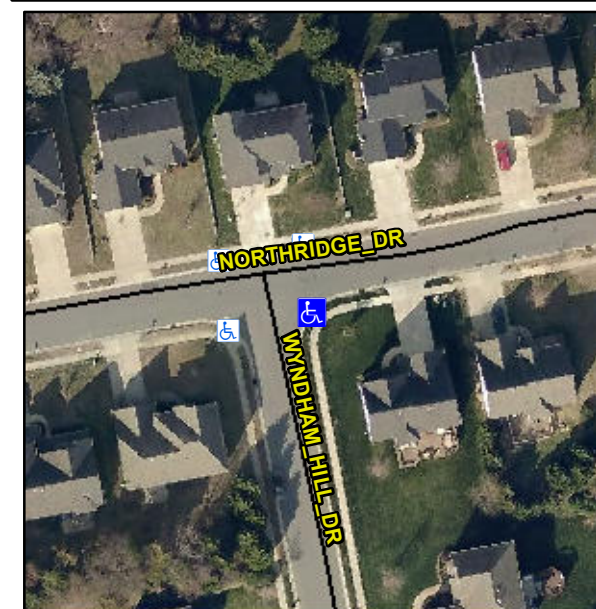
R304.5.1, R304.2.2, R304.5.3

Compliance	Description	Data	Compliance	Description	Data
N/A	Ramp Length (in)	50.0	No	Ramp Slope (%)	10.2
No	Ramp Width (in)	42.0	No	Ramp XSlope (%)	8.8
N/A	Flare Type LT	N/A	N/A	Flare Type RT	N/A
N/A	Flare Slope LT (%)	N/A	N/A	Flare Slope RT (%)	N/A
N/A	Flare Traversable LT?	N/A	N/A	Flare Traversable RT?	N/A
N/A	Landing Length (in)	N/A	N/A	DWS Provided?	N/A
N/A	Landing Width (in)	N/A	N/A	DWS Contrast?	N/A
N/A	Landing Slope (%)	N/A	N/A	DWS Length (in)	N/A
N/A	Landing X Slope (%)	N/A	N/A	DWS Full Width?	N/A
N/A	Landing Curb? (Y/N)	N/A	N/A	DWS Offset (in)	N/A
N/A	Shared Landing?	N/A			
N/A	Gutter Ponding?	N/A	N/A	Gutter Slope (%)	N/A
N/A	Gutter Lip Ht (in)	N/A	N/A	Gutter X Slope (%)	N/A
N/A	Painted X Walk1?	No	N/A	Painted X Walk2?	No
	X Walk 1 Direction	To N		X Walk 2 Direction	To W
N/A	X Walk 1 Width (in)	N/A	N/A	X Walk 2 Width (in)	N/A
	X Walk 1 Slope (%)	1.4		X Walk 2 Slope (%)	4.6
	X Walk 1 X Slope (%)	7.7		X Walk 2 X Slope (%)	3.5

N/A	Ramp inside XWalk1?	N/A	N/A	Ramp inside XWalk2?	N/A
	Road Slope (%)	6.8	N/A	Clear Space?	N/A
	Road X Slope (%)	3.2	N/A	Clear Space to XWalk (in)	N/A
N/A	Any Obstructions?	N/A	N/A	Storm Grate/Utility Hazard?	N/A
	Obstruction Type			Storm Grate/Utility Type	
		N/A			N/A
			Yes	Surface Condition? (G/P)	Good

Remove & Replace Curb Ramp With Two New Directional Ramps or Equivalent.
