Access Compliance Report Public Rights-of-Way (Curb Ramps)

Intersection ID: 49292	9292 Main Street: ROYAL_WINCHESTER_DR				ross Street: CHAMBERLIN_RD				Location:	SE
ADA ID: A52F4FC2D9	27 Ramp Ty	Ramp Type: PerpDiag				ail: Pass Overall	o Severity Score:	0		
Codes/Mitigation Info/Possible Solution					Field Measurements/Component Compliance					
		Possible Solutions:			Compliance Description		Data Compliance Description			Data
		Remove & Replace Curb Rar Two New Directional Ramps Equivalent. Remove & Repla Gutter.	rb Ramp	With	N/A	Ramp Length (in)	71.0	Yes	Ramp Slope (%)	8.2
			Ramps or		Yes	Ramp Width (in)	48.0	Yes	Ramp XSlope (%)	2.0
	18/1 /1			N/A	Flare Type LT	Sloped	N/A	Flare Type RT	N/A	
	01/18.				N/A	Flare Slope LT (%)	7.0	Yes	Flare Slope RT (%)	4.5
$x \setminus x$					N/A	Flare Traversable LT?	Yes	N/A	Flare Traversable RT?	Yes
	Radia /				Yes	Landing Length (in)	48.0	Yes	DWS Provided?	Yes
A A MARIE	18 6	Surveyor Notes:			Yes	Landing Width (in)	48.0	Yes	DWS Contrast?	Yes

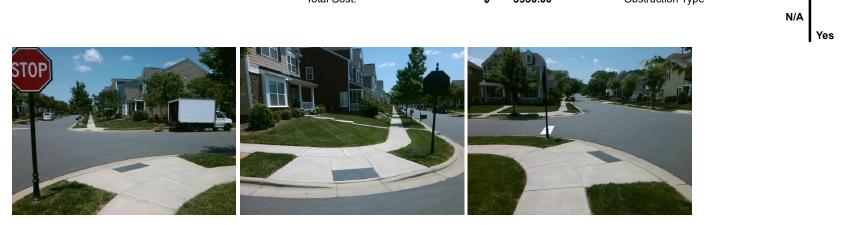
6. Chi	N/A			No	Landing Slope (%)	2.3	Yes	DWS Length (in)	24.0	
				No	Landing X Slope (%)	2.5	Yes	DWS Full Width?	Yes	
6					N/A	Landing Curb? (Y/N)	No	No	DWS Offset (in)	4.0
					N/A	Shared Landing?	No			
	PROW/ADA:			Yes	Gutter Ponding?	No	Yes	Gutter Slope (%)	1.0	
	Not Found, R304.2.2-P	orn R30	432-	Yes	Gutter Lip Ht (in)	0.0	No	Gutter X Slope (%)	2.6	
Para, R304.5.3, R305.2				0.2	N/A	Painted X Walk1?	No	N/A	Painted X Walk2?	No
						X Walk 1 Direction	To NW		X Walk 2 Direction	To SW
					N/A	X Walk 1 Width (in)	N/A	N/A	X Walk 2 Width (in)	N/A
Street 1 Name	CHAMBERLIN RD	-				X Walk 1 Slope (%)	5.8		X Walk 2 Slope (%)	0.5
Stop Condition-Street 2	None					X Walk 1 X Slope (%)	0.1		X Walk 2 X Slope (%)	4.8
Street 2 Name	ROYAL WINCHESTER DR				N/A	Ramp inside XWalk1?	N/A	N/A	Ramp inside XWalk2?	N/A
Stop Condition-Street 1	StopSign					Road Slope (%)	2.3	N/A	Clear Space?	Yes
						Road X Slope (%)	4.0	N/A	Clear Space to XWalk (in)	N/A

Yes	Any Obstructions?	No	Yes	Storm Grate/Utility Hazard?	No
		Total Cost:	\$	3950.00		Obstruction Type			Storm Grate/Utility Type	
			-				N/A			N/A
