# Access Compliance Report

## Public Rights-of-Way

### (Curb Ramps)

Intersection ID: 8813	Main Street: JENNINGS_ST	Cross Street: N/A	Location: SW
ADA ID: A53C719C364B	Ramp Type: Perp	Initial Pass/Fail: Fail	Overall Compliance: No
		Severity Score: 25

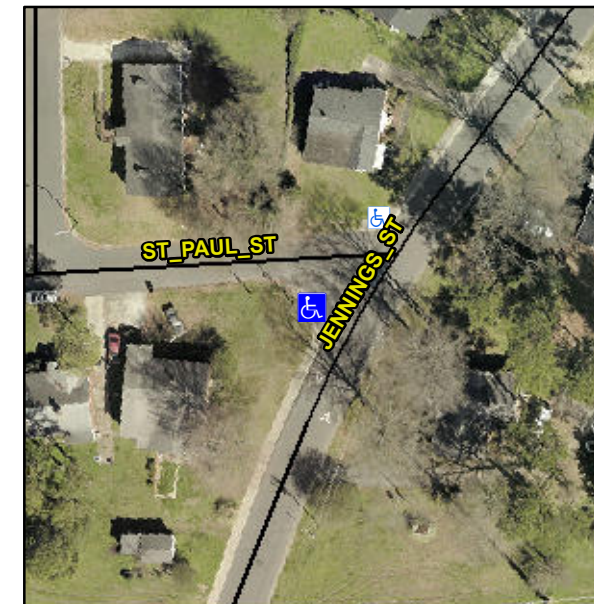
**Not Found, R304.5.3**

Compliance	Description	Data	Compliance	Description	Data
N/A	Ramp Length (in)	58.5	Yes	Ramp Slope (%)	6.3
Yes	Ramp Width (in)	103.0	No	Ramp XSlope (%)	15.0
N/A	Flare Type LT	N/A	N/A	Flare Type RT	N/A
N/A	Flare Slope LT (%)	N/A	N/A	Flare Slope RT (%)	N/A
N/A	Flare Traversable LT?	N/A	N/A	Flare Traversable RT?	N/A
N/A	Landing Length (in)	N/A	N/A	DWS Provided?	N/A
N/A	Landing Width (in)	N/A	N/A	DWS Contrast?	N/A
N/A	Landing Slope (%)	N/A	N/A	DWS Length (in)	N/A
N/A	Landing X Slope (%)	N/A	N/A	DWS Full Width?	N/A
N/A	Landing Curb? (Y/N)	N/A	N/A	DWS Offset (in)	N/A
N/A	Shared Landing?	N/A			
N/A	Gutter Ponding?	N/A	N/A	Gutter Slope (%)	N/A
N/A	Gutter Lip Ht (in)	N/A	N/A	Gutter X Slope (%)	N/A
N/A	Painted X Walk1?	No	N/A	Painted X Walk2?	N/A
	X Walk 1 Direction	To NE		X Walk 2 Direction	N/A
N/A	X Walk 1 Width (in)	N/A	N/A	X Walk 2 Width (in)	N/A
	X Walk 1 Slope (%)	0.7		X Walk 2 Slope (%)	N/A
	X Walk 1 X Slope (%)	7.4		X Walk 2 X Slope (%)	N/A

**Remove & Replace Entire Ramp.**
