Access Compliance Report Public Rights-of-Way (Curb Ramps)

Intersection ID: 44025 Main Street: EASTWAY DR **Cross Street: EASTWAY DR RA** Location: NE ADA ID: A53FF968AB3B Ramp Type: Perp Initial Pass/Fail: Fail **Overall Compliance: No Severity Score:** 60

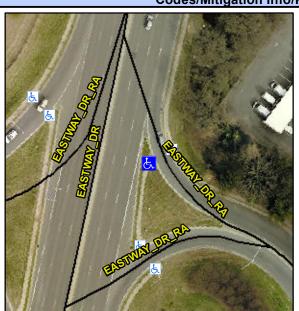
74.5 No

31.0 No

-055ibie 30iutioii
Possible Solutions:
Remove & Replace Entire Ramp.
Surveyor Notes:
N/A
PROW/ADA:
Not Found, R304.5.1, R304.2.2, R304.5.3
