# Access Compliance Report

## Public Rights-of-Way

| Intersection ID: 7147 | Main Street: KINGVILLE_DR | Cross Street: MALAGANT_LN | Location: SE |
| ADA ID: A5450DE8F9EC | Ramp Type: Directional1 | Initial Pass/Fail: Pass | Overall Compliance: No |

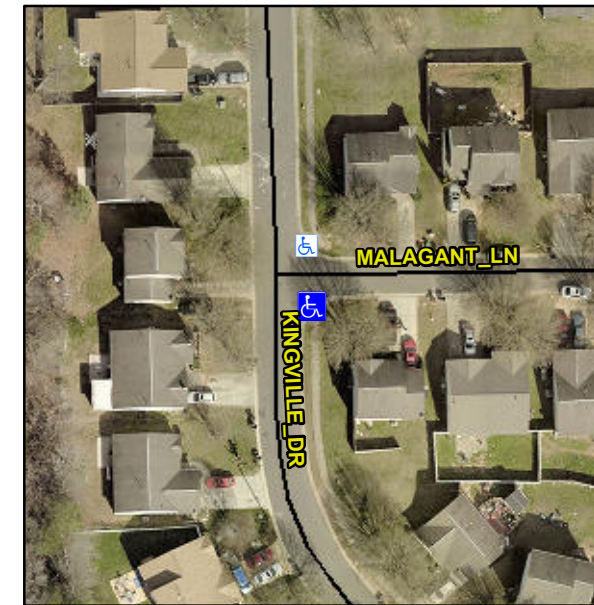
**Not Found, R304.2.2-Perp, R304.3.2-  
Para, R304.5.3, R305, R302.7.2**

| Compliance | Description | Data | Compliance | Description | Data |
|---|---|---|---|---|---|
| Yes | Ramp Width (in) | 48.0 | No | Grade Break Slope (%) | 7.5 |
| Yes | Landing Length (in) | 65.0 | No | DWS Provided? | No |
| No | Landing Slope (%) | 5.7 | N/A | DWS Length (in) | N/A |
| No | Gutter Lip Ht (in) | 0.5 | No | Gutter X Slope (%) | 6.8 |

**Remove & Replace Entire Ramp.  
Remove & Replace Gutter.**
