Access Compliance Report

Public Rights-of-Way

(Curb Ramps)

Intersection ID: 8511	Main Street: MCARTHUR_AV	Cross Street: POINSETT_ST	Location: NW
ADA ID: A54AED52AD45	Ramp Type: Perp	Initial Pass/Fail: Fail	Overall Compliance: No
		Severity Score: 47.5

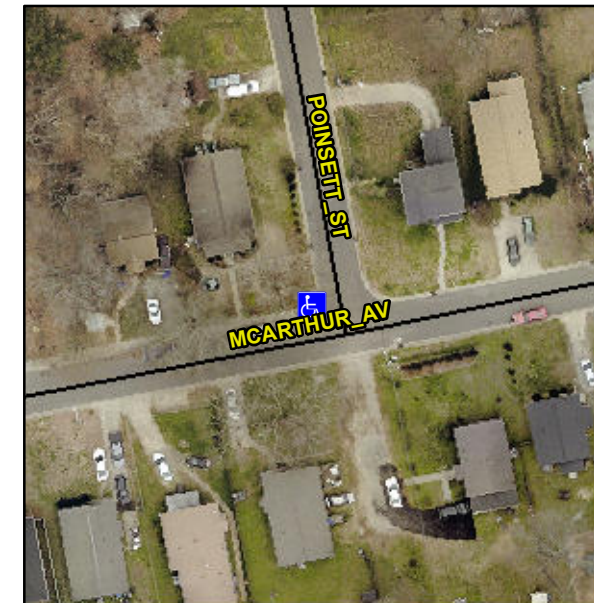
Not Found, R304.5.1, R304.2.2

Compliance	Description	Data	Compliance	Description	Data
N/A	Ramp Length (in)	49.0	No	Ramp Slope (%)	10.7
No	Ramp Width (in)	27.5	Yes	Ramp XSlope (%)	0.6
N/A	Flare Type LT	N/A	N/A	Flare Type RT	N/A
N/A	Flare Slope LT (%)	N/A	N/A	Flare Slope RT (%)	N/A
N/A	Flare Traversable LT?	N/A	N/A	Flare Traversable RT?	N/A
N/A	Landing Length (in)	N/A	N/A	DWS Provided?	N/A
N/A	Landing Width (in)	N/A	N/A	DWS Contrast?	N/A
N/A	Landing Slope (%)	N/A	N/A	DWS Length (in)	N/A
N/A	Landing X Slope (%)	N/A	N/A	DWS Full Width?	N/A
N/A	Landing Curb? (Y/N)	N/A	N/A	DWS Offset (in)	N/A
N/A	Shared Landing?	N/A			
N/A	Gutter Ponding?	N/A	N/A	Gutter Slope (%)	N/A
N/A	Gutter Lip Ht (in)	0.5	N/A	Gutter X Slope (%)	N/A
N/A	Painted X Walk1?	No	N/A	Painted X Walk2?	N/A
	X Walk 1 Direction	To SE		X Walk 2 Direction	N/A
N/A	X Walk 1 Width (in)	N/A	N/A	X Walk 2 Width (in)	N/A
	X Walk 1 Slope (%)	3.3		X Walk 2 Slope (%)	N/A
	X Walk 1 X Slope (%)	3.5		X Walk 2 X Slope (%)	N/A

Remove & Replace Entire Ramp.
