## Access Compliance Report Public Rights-of-Way (Curb Ramps)

| Interpotion ID: 21122 | Main Str | | | Croco | Streat | | M | | Logation | w |
|--|---|---|---|---|---|---|---|---|---|---|
| Intersection ID: 21132 | Main Street: W_ARROWOOD_RD | | | | Cross Street: SOUTHERN_PINE_BV | | | | Location: | vv |
| ADA ID: A5755613BA24 | Ramp Type: MedianPerp | | | Initial | nitial Pass/Fail: Pass Overall Compliance: No | | | | o Severity Score: | 0 |

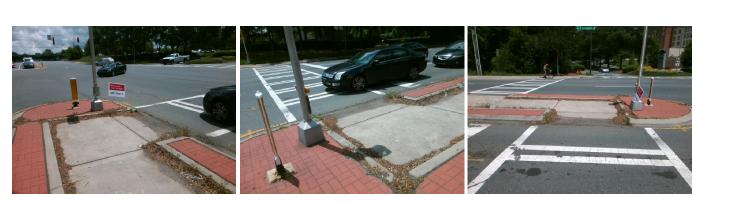
| Interpotion ID: 21122 | Main Str | | | Croco | Streat | | M | | Logation | w |
|--|---|---|---|---|---|---|---|---|---|---|
| | | N/A | | | No | Landing Slope (%) | 3.3 | Yes | DWS Length (in) | 24.0 |
| | La Charles | Not Found, R304.2.2- | Perp. R30 | 4.3.2- | Yes | Gutter Lip Ht (in) | 0.0 | Yes | Gutter X Slope (%) | 0.5 |

| Interpotion ID: 21122 | Main Str | | | Croco | Streat | | M | | Logation | w |
|--|---|---|---|---|---|---|---|---|---|---|
| a start and a start a s | | Remove & Replace E | ntire Ram | <b>p</b> . | N/A | Ramp Length (in) | 47.0 | Yes | Ramp Slope (%) | 6.1 |
