# Access Compliance Report

## Public Rights-of-Way

### (Curb Ramps)

| Intersection ID: 50587 | Main Street: DOWNY_BIRCH_RD | Cross Street: GREAT_LAUREL_RD | Location: NE |

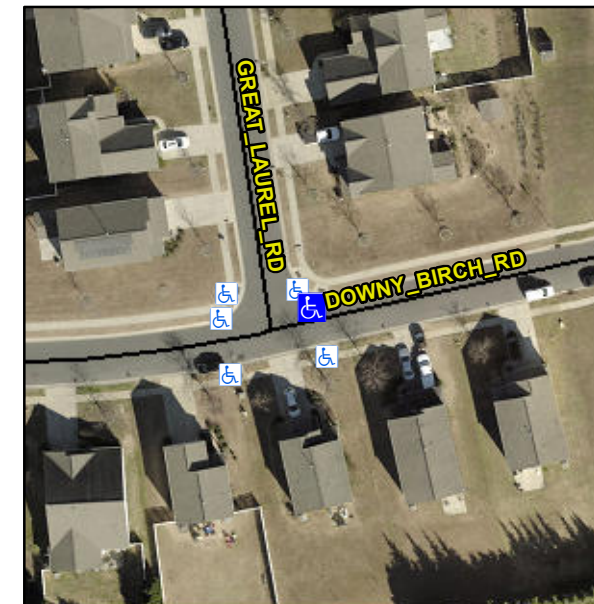
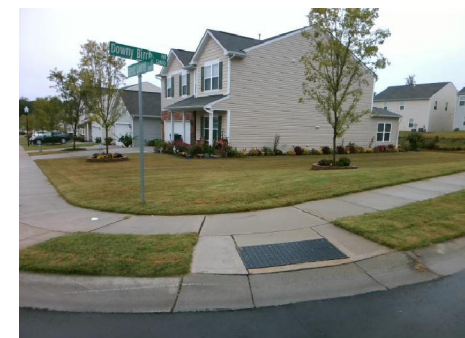
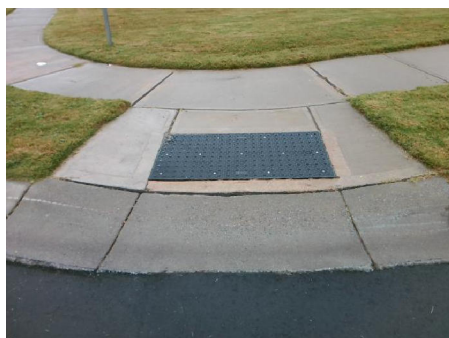
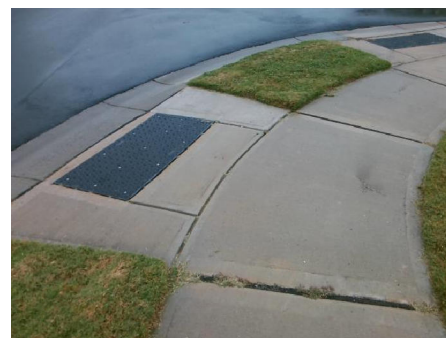
| ADA ID: A594F1C21311 | Ramp Type: BlendTrans1 | Initial Pass/Fail: Fail | Overall Compliance: No |

**Not Found, R304.5.1, R304.5.3**

| Compliance | Description | Data | Compliance | Description | Data |
|---|---|---|---|---|---|
| No | Ramp Width (in) | 45.0 | No | BlendTrans XSlope (%) | 5.1 |

**Remove & Replace Curb Ramp With Two New Directional Ramps or Equivalent.**
