# Access Compliance Report

## Public Rights-of-Way

### (Curb Ramps)

Intersection ID: 25333	Main Street: CARMEL_RD	Cross Street: MEADOWRIDGE_DR	Location:	N
ADA ID: A5A3A527CB48	Ramp Type: PerpDiag	Initial Pass/Fail: Fail	Overall Compliance: No	Severity Score: 21.25

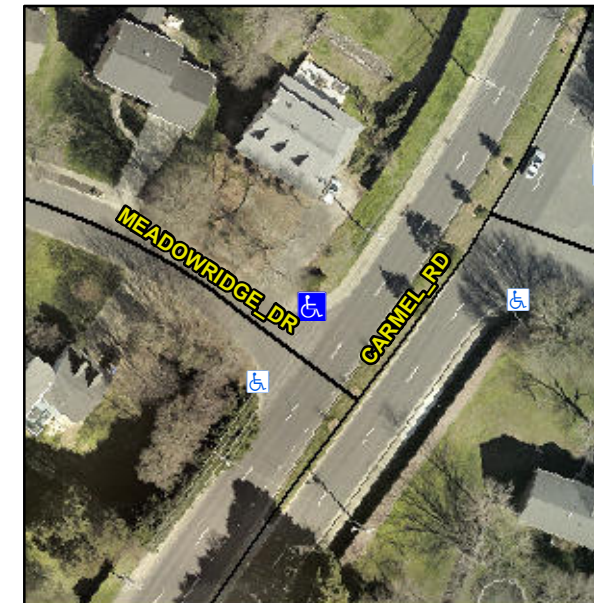
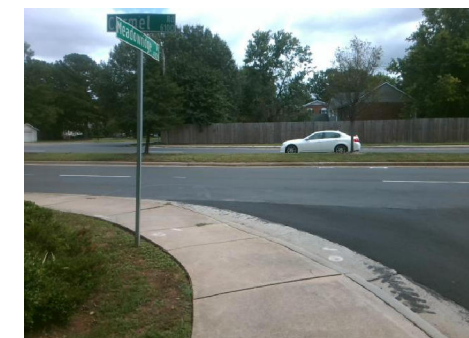
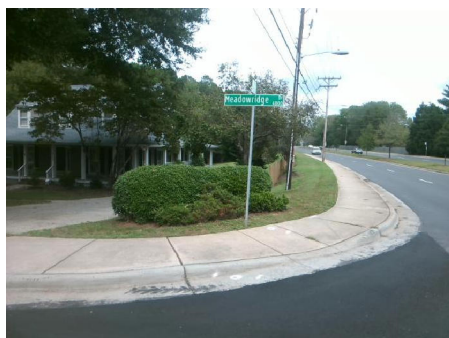
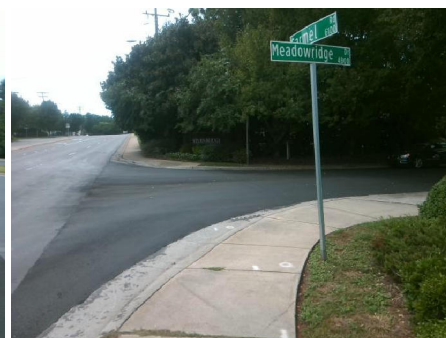
**Not Found, R304.5.1, R304.2.2**

Compliance	Description	Data	Compliance	Description	Data
N/A	Ramp Length (in)	59.0	No	Ramp Slope (%)	10.2
No	Ramp Width (in)	38.5	Yes	Ramp XSlope (%)	0.7
N/A	Flare Type LT	N/A	N/A	Flare Type RT	N/A
N/A	Flare Slope LT (%)	N/A	N/A	Flare Slope RT (%)	N/A
N/A	Flare Traversable LT?	N/A	N/A	Flare Traversable RT?	N/A
N/A	Landing Length (in)	N/A	N/A	DWS Provided?	N/A
N/A	Landing Width (in)	N/A	N/A	DWS Contrast?	N/A
N/A	Landing Slope (%)	N/A	N/A	DWS Length (in)	N/A
N/A	Landing X Slope (%)	N/A	N/A	DWS Full Width?	N/A
N/A	Landing Curb? (Y/N)	N/A	N/A	DWS Offset (in)	N/A
N/A	Shared Landing?	N/A			
N/A	Gutter Ponding?	N/A	N/A	Gutter Slope (%)	N/A
N/A	Gutter Lip Ht (in)	N/A	N/A	Gutter X Slope (%)	N/A
N/A	Painted X Walk1?	No	N/A	Painted X Walk2?	No
	X Walk 1 Direction	To SW		X Walk 2 Direction	To SE
N/A	X Walk 1 Width (in)	N/A	N/A	X Walk 2 Width (in)	N/A
	X Walk 1 Slope (%)	0.2		X Walk 2 Slope (%)	0.5
	X Walk 1 X Slope (%)	3.1		X Walk 2 X Slope (%)	0.7

N/A	Ramp inside XWalk1?	N/A	N/A	Ramp inside XWalk2?	N/A
	Road Slope (%)	0.9	N/A	Clear Space?	N/A
	Road X Slope (%)	2.7	N/A	Clear Space to XWalk (in)	N/A
N/A	Any Obstructions?	N/A	N/A	Storm Grate/Utility Hazard?	N/A
	Obstruction Type			Storm Grate/Utility Type	
		N/A			N/A
		Yes		Surface Condition? (G/P)	Good

**Remove & Replace Curb Ramp With Two New Directional Ramps or Equivalent.**
