# Access Compliance Report

## Public Rights-of-Way

### (Curb Ramps)

| Intersection ID: 22230 | Main Street: N_SARDIS_VIEW_LN | Cross Street: SARDIS_RD | Location: SE |

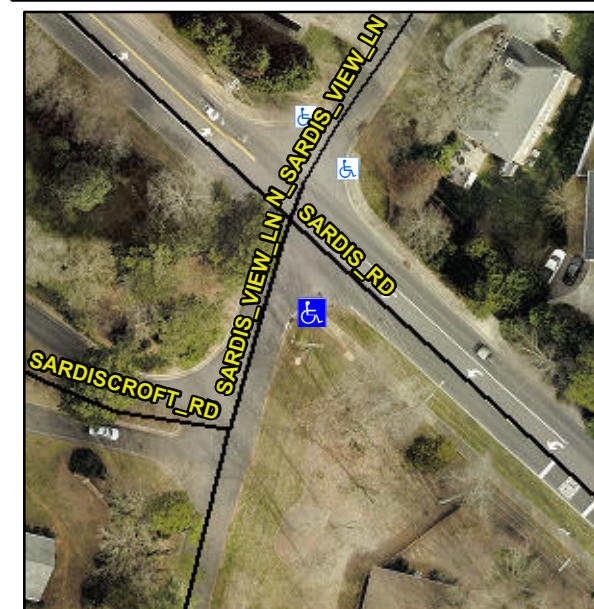
| ADA ID: A5BA11E40BA0 | Ramp Type: Directional1 | Initial Pass/Fail: Fail | Overall Compliance: No |
| Severity Score: 25 | | | |

**R304.2.2, R304.5.3**

| Compliance | Description | Data | Compliance | Description | Data |
|---|---|---|---|---|---|
| No | Ramp Slope (%) | 10.3 | N/A | Grade Break XSlope (%) | 0.0 |
| No | Ramp XSlope (%) | 6.3 | | | |

**Remove & Replace Entire Ramp.**

Total Cost: \$ 1600.00
