Access Compliance Report

Public Rights-of-Way

(Curb Ramps)

Intersection ID: N/A	Main Street: BALLANTYNE_VILLAGE_DR	Cross Street: N/A	Location: NE
ADA ID: A5BFD18F7730	Ramp Type: Perp	Initial Pass/Fail: Fail	Overall Compliance: No
Severity Score: 25			
Codes/Mitigation Info/Possible Solution		Field Measurements/Component Compliance

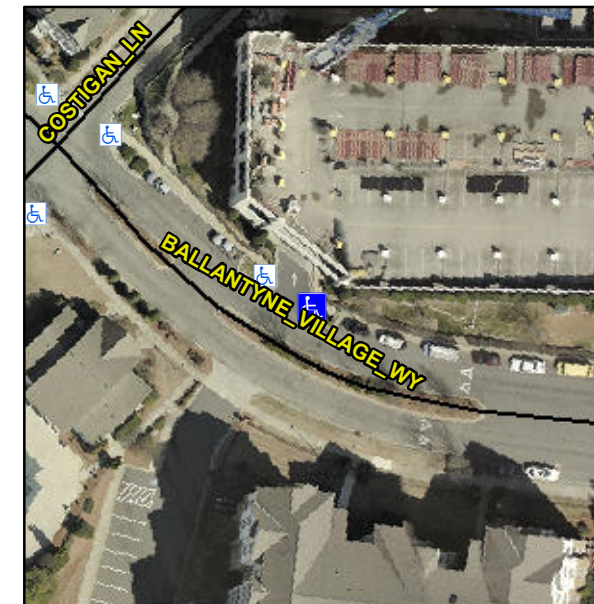
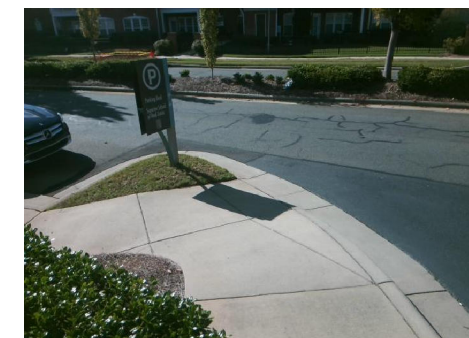
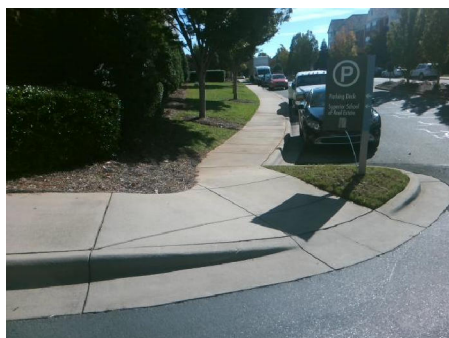
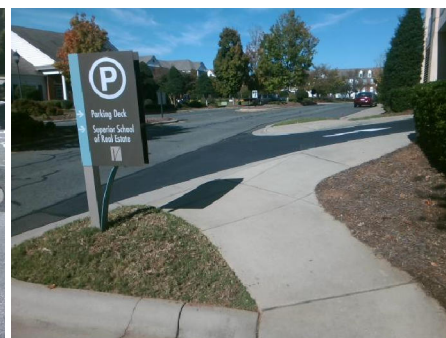
Not Found, R304.5.3

Compliance	Description	Data	Compliance	Description	Data
N/A	Ramp Length (in)	70.0	Yes	Ramp Slope (%)	6.8
Yes	Ramp Width (in)	59.0	No	Ramp XSlope (%)	10.2
N/A	Flare Type LT	N/A	N/A	Flare Type RT	N/A
N/A	Flare Slope LT (%)	N/A	N/A	Flare Slope RT (%)	N/A
N/A	Flare Traversable LT?	N/A	N/A	Flare Traversable RT?	N/A
N/A	Landing Length (in)	N/A	N/A	DWS Provided?	N/A
N/A	Landing Width (in)	N/A	N/A	DWS Contrast?	N/A
N/A	Landing Slope (%)	N/A	N/A	DWS Length (in)	N/A
N/A	Landing X Slope (%)	N/A	N/A	DWS Full Width?	N/A
N/A	Landing Curb? (Y/N)	N/A	N/A	DWS Offset (in)	N/A
N/A	Shared Landing?	N/A			
N/A	Gutter Ponding?	N/A	N/A	Gutter Slope (%)	N/A
N/A	Gutter Lip Ht (in)	N/A	N/A	Gutter X Slope (%)	N/A
N/A	Painted X Walk1?	No	N/A	Painted X Walk2?	N/A
	X Walk 1 Direction	To NW		X Walk 2 Direction	N/A
N/A	X Walk 1 Width (in)	N/A	N/A	X Walk 2 Width (in)	N/A
	X Walk 1 Slope (%)	3.8		X Walk 2 Slope (%)	N/A
	X Walk 1 X Slope (%)	11.4		X Walk 2 X Slope (%)	N/A

N/A	Ramp inside XWalk1?	N/A	N/A	Ramp inside XWalk2?	N/A
	Road Slope (%)	N/A	N/A	Clear Space?	N/A
	Road X Slope (%)	N/A	N/A	Clear Space to XWalk (in)	N/A
N/A	Any Obstructions?	N/A	N/A	Storm Grate/Utility Hazard?	N/A
	Obstruction Type			Storm Grate/Utility Type	
		N/A			N/A
			Yes	Surface Condition? (G/P)	Good

Remove & Replace Entire Ramp.

Total Cost: \$ 1850.00
