Access Compliance Report Public Rights-of-Way (Curb Ramps)

Intersection ID: 46372 Main Street: ROYAL_CASTLE_CT Cross Street: STRONVAR_HOUSE_LN Location: E

ADA ID: A5CB4CD36092 Ramp Type: PerpDiag Initial Pass/Fail: Fail Overall Compliance: No Severity Score: 46.25

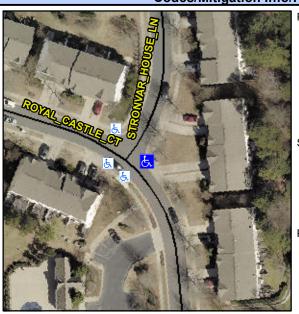
Compliance Description <u>Data</u> Compliance Description Data No N/A Ramp Length (in) 48.0 Ramp Slope (%) 11.3 No No Ramp Width (in) 47.0 Ramp XSlope (%) 8.2 N/A N/A Flare Type LT N/A Flare Type RT N/A N/A N/A N/A Flare Slope RT (%) N/A Flare Slope LT (%) N/A Flare Traversable LT? N/A N/A Flare Traversable RT? N/A N/A N/A N/A DWS Provided? N/A Landing Length (in) N/A Landing Width (in) N/A N/A **DWS Contrast?** N/A N/A N/A N/A Landing Slope (%) DWS Length (in) N/A N/A Landing X Slope (%) N/A N/A DWS Full Width? N/A N/A Landing Curb? (Y/N) N/A N/A DWS Offset (in) N/A N/A N/A Shared Landing? N/A **Gutter Ponding?** N/A N/A Gutter Slope (%) N/A N/A Gutter Lip Ht (in) N/A N/A Gutter X Slope (%) N/A N/A Painted X Walk1? No N/A Painted X Walk2? No X Walk 1 Direction To NW X Walk 2 Direction To SW N/A N/A X Walk 1 Width (in) X Walk 2 Width (in) N/A X Walk 1 Slope (%) 4.6 X Walk 2 Slope (%) 1.2 X Walk 1 X Slope (%) 1.9 X Walk 2 X Slope (%) 2.6 N/A N/A N/A Ramp inside XWalk2? N/A Ramp inside XWalk1? Road Slope (%) 4.0 N/A Clear Space? N/A N/A Road X Slope (%) 0.0 Clear Space to XWalk (in) N/A N/A N/A N/A Any Obstructions? Storm Grate/Utility Hazard? N/A **Obstruction Type** Storm Grate/Utility Type N/A N/A

Remove & Replace Curb Ramp With
Two New Directional Ramps or
Equivalent.

PROW/ADA:
R304.5.1, R304.2.2, R304.5.3
