Access Compliance Report

Public Rights-of-Way

(Curb Ramps)

| Intersection ID: 16746 | Main Street: PRINCETON_AV | Cross Street: STERLING_RD | Location: NW |

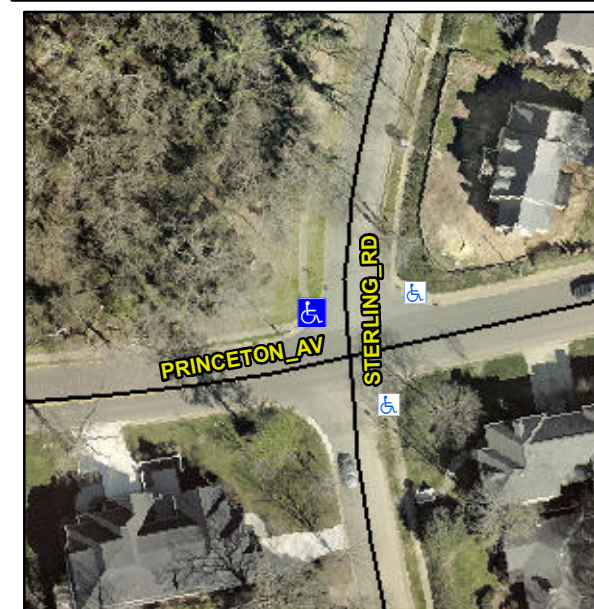
| ADA ID: A5D4B45C706A | Ramp Type: PerpDiag | Initial Pass/Fail: Fail | Overall Compliance: No |
| Severity Score: 50 | | | |

R304.2.2, R304.5.3

| Compliance | Description | Data | Compliance | Description | Data |
|---|---|---|---|---|---|
| N/A | Ramp Length (in) | 54.0 | No | Ramp Slope (%) | 14.8 |
| Yes | Ramp Width (in) | 60.0 | No | Ramp XSlope (%) | 12.4 |

Remove & Replace Curb Ramp With Two New Directional Ramps or Equivalent.
