Access Compliance Report Public Rights-of-Way (Curb Ramps)

Intersection ID: 22882Main Street: SARDIS_POINTE_RDCross Street: SARDIS_RDLocation: NWADA ID: A5D523FA4410Ramp Type: PerpInitial Pass/Fail: FailOverall Compliance: NoSeverity Score: 13.75

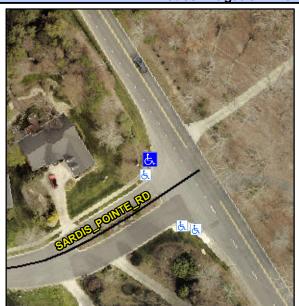
Field Measurements/Component Compliance						
Compliance Description		Data	Comp	oliance Description	Data	
N/A	A Ramp Length (in)	47.0	No	Ramp Slope (%)	9.2	
Ye	s Ramp Width (in)	48.0	No	Ramp XSlope (%)	2.2	
N/A	A Flare Type LT	N/A	N/A	Flare Type RT	N/A	
N/A	A Flare Slope LT (%)	N/A	N/A	Flare Slope RT (%)	N/A	
N/A	A Flare Traversable LT?	N/A	N/A	Flare Traversable RT?	N/A	
N/A	A Landing Length (in)	N/A	N/A	DWS Provided?	N/A	
N/A	A Landing Width (in)	N/A	N/A	DWS Contrast?	N/A	
N/A	A Landing Slope (%)	N/A	N/A	DWS Length (in)	N/A	
N/A	A Landing X Slope (%)	N/A	N/A	DWS Full Width?	N/A	
N/A	A Landing Curb? (Y/N)	N/A	N/A	DWS Offset (in)	N/A	
N/A	A Shared Landing?	N/A				
N/A	A Gutter Ponding?	N/A	N/A	Gutter Slope (%)	N/A	
N/A	Gutter Lip Ht (in)	N/A	N/A	Gutter X Slope (%)	N/A	
N/A	A Painted X Walk1?	No	N/A	Painted X Walk2?	N/A	
	X Walk 1 Direction	To NE		X Walk 2 Direction	N/A	
N/A	X Walk 1 Width (in)	N/A	N/A	X Walk 2 Width (in)	N/A

X Walk 1 Slope (%)	1.9		X Walk 2 Slope (%)	N/A	
	X Walk 1 X Slope (%)	1.8		X Walk 2 X Slope (%)	N/A	
N/A	A Ramp inside XWalk1?	N/A	N/A	Ramp inside XWalk2?	N/A	
	Road Slope (%)	N/A	N/A	Clear Space?	N/A	
	Road X Slope (%)	N/A	N/A	Clear Space to XWalk (in)	N/A	
N/A	Any Obstructions?	N/A	N/A	Storm Grate/Utility Hazard?	N/A	
	Obstruction Type			Storm Grate/Utility Type		
		N/A			N/A	
			Yes	Surface Condition? (G/P)	Good

Possible Solutions:	Co
Remove & Replace Entire Ramp.	N/A
•	Yes
	N/A
	N/A
	N/A
	N/A
Surveyor Notes:	N/A
N/A	N/A
	N/A
	N/A
	N/A
PROW/ADA:	N/A
R304.2.2, R304.5.3	N/A
,	N/A
	N/A
	N/A

Total Cost: \$ 1850.00
