# Access Compliance Report

## Public Rights-of-Way

Intersection ID: N/A	Main Street: NEW_FASHION_WY	Cross Street: OUTLETS_BV	Location: SW
ADA ID: A5DAF069799C	Ramp Type: Perp	Initial Pass/Fail: Fail	Overall Compliance: No
Severity Score: 33.75			
Codes/Mitigation Info/Possible Solution		Field Measurements/Component Compliance

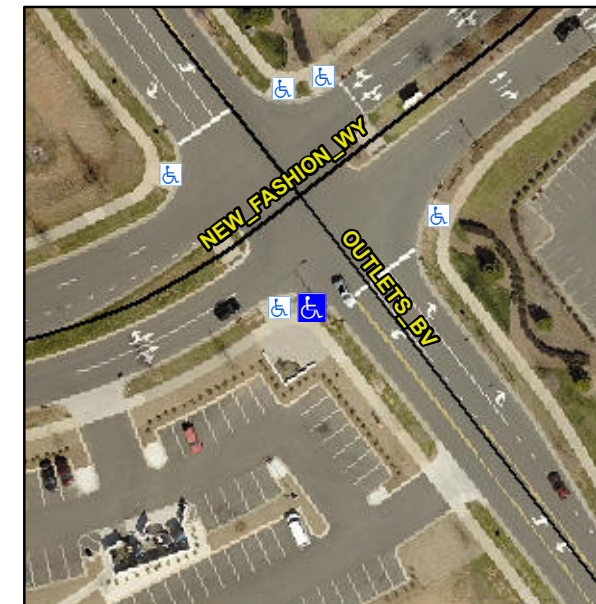
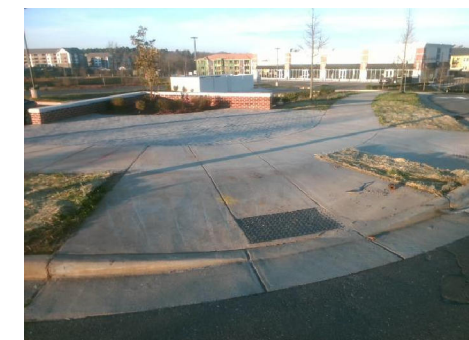
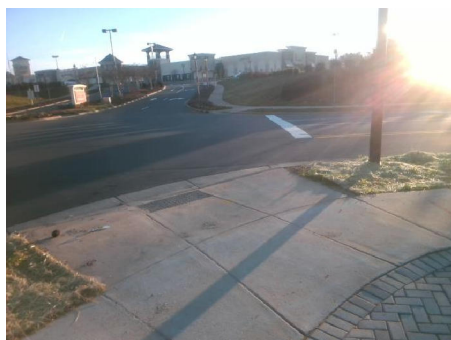
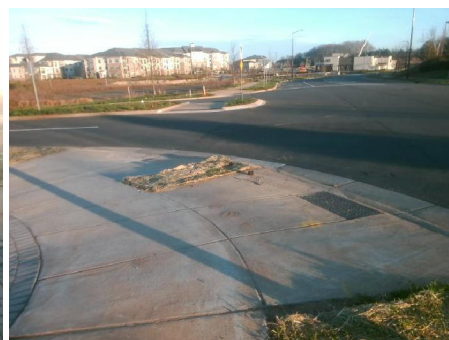
**R304.5.1, R304.2.2, R304.5.3**

Compliance	Description	Data	Compliance	Description	Data
N/A	Ramp Length (in)	93.5	No	Ramp Slope (%)	8.6
No	Ramp Width (in)	47.0	No	Ramp XSlope (%)	5.1
N/A	Flare Type LT	N/A	N/A	Flare Type RT	N/A
N/A	Flare Slope LT (%)	N/A	N/A	Flare Slope RT (%)	N/A
N/A	Flare Traversable LT?	N/A	N/A	Flare Traversable RT?	N/A
N/A	Landing Length (in)	N/A	N/A	DWS Provided?	N/A
N/A	Landing Width (in)	N/A	N/A	DWS Contrast?	N/A
N/A	Landing Slope (%)	N/A	N/A	DWS Length (in)	N/A
N/A	Landing X Slope (%)	N/A	N/A	DWS Full Width?	N/A
N/A	Landing Curb? (Y/N)	N/A	N/A	DWS Offset (in)	N/A
N/A	Shared Landing?	N/A			
N/A	Gutter Ponding?	N/A	N/A	Gutter Slope (%)	N/A
N/A	Gutter Lip Ht (in)	N/A	N/A	Gutter X Slope (%)	N/A
N/A	Painted X Walk1?	No	N/A	Painted X Walk2?	N/A
	X Walk 1 Direction	To NE		X Walk 2 Direction	N/A
N/A	X Walk 1 Width (in)	N/A	N/A	X Walk 2 Width (in)	N/A
	X Walk 1 Slope (%)	3.5		X Walk 2 Slope (%)	N/A
	X Walk 1 X Slope (%)	0.3		X Walk 2 X Slope (%)	N/A

N/A	Ramp inside XWalk1?	N/A	N/A	Ramp inside XWalk2?	N/A
	Road Slope (%)	N/A	N/A	Clear Space?	N/A
	Road X Slope (%)	N/A	N/A	Clear Space to XWalk (in)	N/A
N/A	Any Obstructions?	N/A	N/A	Storm Grate/Utility Hazard?	N/A
	Obstruction Type			Storm Grate/Utility Type	
		N/A			N/A
			Yes	Surface Condition? (G/P)	Good

**Remove & Replace Entire Ramp.**
