Access Compliance Report

Public Rights-of-Way

(Curb Ramps)

Intersection ID: 5576	Main Street: BELLHAVEN_BV	Cross Street: COULWOOD_PARK_DR	Location: E
ADA ID: A5F7465838B5	Ramp Type: Perp	Initial Pass/Fail: Fail	Overall Compliance: No
		Severity Score: 12.5

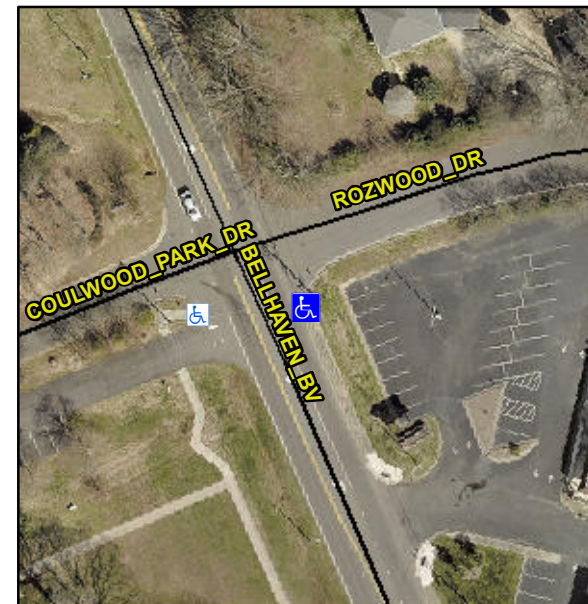
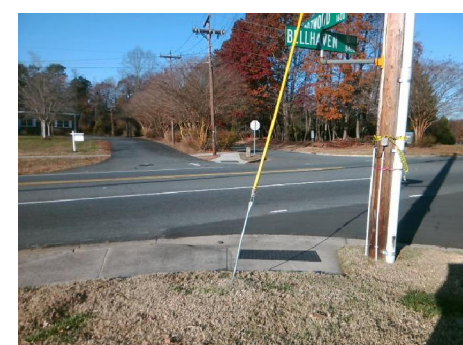
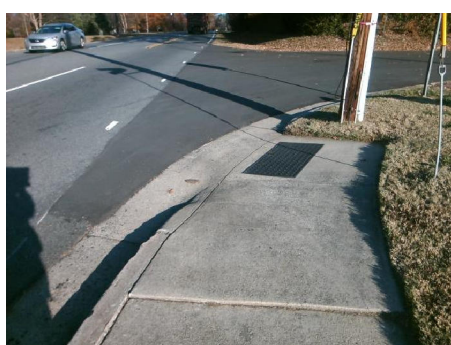
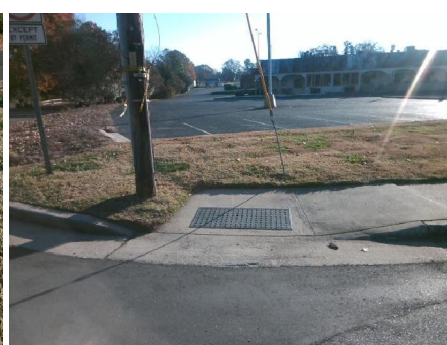
R304.2.2

Compliance	Description	Data	Compliance	Description	Data
N/A	Ramp Length (in)	60.0	No	Ramp Slope (%)	8.4
Yes	Ramp Width (in)	60.5	Yes	Ramp XSlope (%)	1.5
N/A	Flare Type LT	N/A	N/A	Flare Type RT	N/A
N/A	Flare Slope LT (%)	N/A	N/A	Flare Slope RT (%)	N/A
N/A	Flare Traversable LT?	N/A	N/A	Flare Traversable RT?	N/A
N/A	Landing Length (in)	N/A	N/A	DWS Provided?	N/A
N/A	Landing Width (in)	N/A	N/A	DWS Contrast?	N/A
N/A	Landing Slope (%)	N/A	N/A	DWS Length (in)	N/A
N/A	Landing X Slope (%)	N/A	N/A	DWS Full Width?	N/A
N/A	Landing Curb? (Y/N)	N/A	N/A	DWS Offset (in)	N/A
N/A	Shared Landing?	N/A			
N/A	Gutter Ponding?	N/A	N/A	Gutter Slope (%)	N/A
N/A	Gutter Lip Ht (in)	N/A	N/A	Gutter X Slope (%)	N/A
N/A	Painted X Walk1?	No	N/A	Painted X Walk2?	N/A
	X Walk 1 Direction	To NW		X Walk 2 Direction	N/A
N/A	X Walk 1 Width (in)	N/A	N/A	X Walk 2 Width (in)	N/A
	X Walk 1 Slope (%)	4.4		X Walk 2 Slope (%)	N/A
	X Walk 1 X Slope (%)	3.5		X Walk 2 X Slope (%)	N/A

Remove & Replace Entire Ramp.
