Access Compliance Report

Public Rights-of-Way

(Curb Ramps)

| Intersection ID: 52059 | Main Street: CALDWELL_RD | Cross Street: SERVICE_RD_2_RD | Location: W |

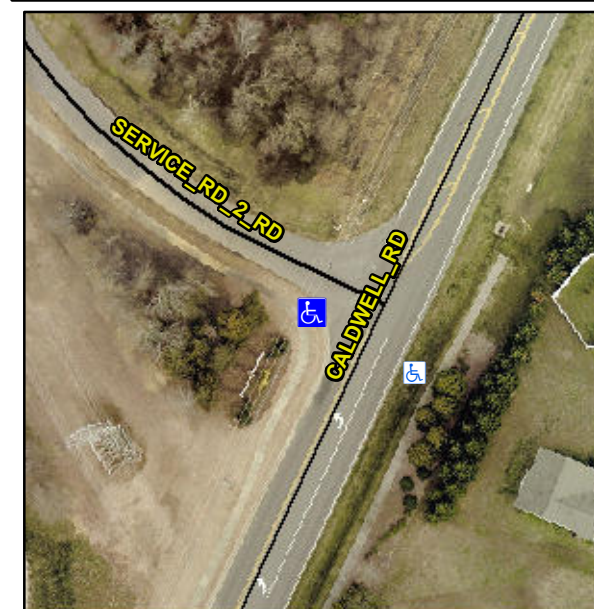
| ADA ID: A5F84BA7E425 | Ramp Type: Perp | Initial Pass/Fail: Fail | Overall Compliance: No |
| Severity Score: 8.75 | | | |

R304.5.1

| Compliance | Description | Data | Compliance | Description | Data |
|---|---|---|---|---|---|
| No | Ramp Width (in) | 47.5 | Yes | Ramp XSlope (%) | 0.9 |

Remove & Replace Entire Ramp.
