Intersection ID: 23691	Main Street: BALTUSROL_LN	Cross Street: N/A	Location:	NE
ADA ID: A5FA939ED8DF	Ramp Type: PerpDiag	Initial Pass/Fail: Fail	Overall Compliance: No	Severity Score: 13.75

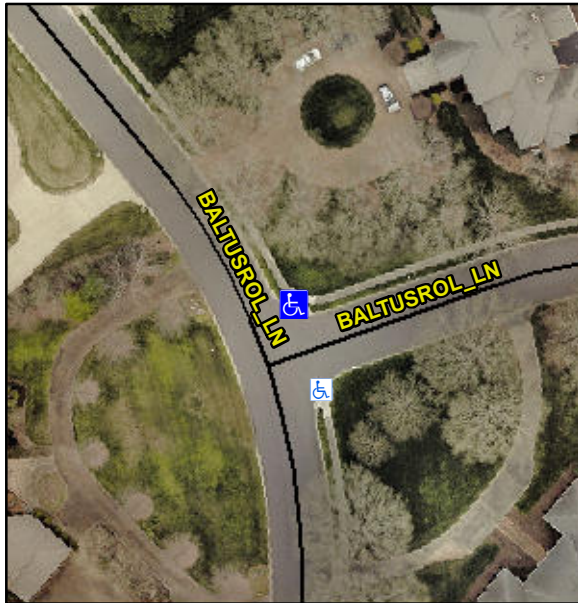
Not Found, R304.2.2, R304.5.3

Compliance	Description	Data	Compliance	Description	Data
N/A	Ramp Length (in)	56.0	No	Ramp Slope (%)	8.6
Yes	Ramp Width (in)	48.0	No	Ramp XSlope (%)	3.4
N/A	Flare Type LT	N/A	N/A	Flare Type RT	N/A
N/A	Flare Slope LT (%)	N/A	N/A	Flare Slope RT (%)	N/A
N/A	Flare Traversable LT?	N/A	N/A	Flare Traversable RT?	N/A
N/A	Landing Length (in)	N/A	N/A	DWS Provided?	N/A
N/A	Landing Width (in)	N/A	N/A	DWS Contrast?	N/A
N/A	Landing Slope (%)	N/A	N/A	DWS Length (in)	N/A
N/A	Landing X Slope (%)	N/A	N/A	DWS Full Width?	N/A
N/A	Landing Curb? (Y/N)	N/A	N/A	DWS Offset (in)	N/A
N/A	Shared Landing?	N/A			
N/A	Gutter Ponding?	N/A	N/A	Gutter Slope (%)	N/A
N/A	Gutter Lip Ht (in)	N/A	N/A	Gutter X Slope (%)	N/A
N/A	Painted X Walk1?	No	N/A	Painted X Walk2?	No
	X Walk 1 Direction	To W		X Walk 2 Direction	To S
N/A	X Walk 1 Width (in)	N/A	N/A	X Walk 2 Width (in)	N/A
	X Walk 1 Slope (%)	3.1		X Walk 2 Slope (%)	0.1
	X Walk 1 X Slope (%)	0.4		X Walk 2 X Slope (%)	3.8

N/A	Ramp inside XWalk1?	N/A	N/A	Ramp inside XWalk2?	N/A
	Road Slope (%)	0.9	N/A	Clear Space?	N/A
	Road X Slope (%)	1.2	N/A	Clear Space to XWalk (in)	N/A
N/A	Any Obstructions?	N/A	N/A	Storm Grate/Utility Hazard?	N/A
	Obstruction Type			Storm Grate/Utility Type	
		N/A			N/A
			Yes	Surface Condition? (G/P)	Good

Possible Solutions:

Remove & Replace Curb Ramp With Two New Directional Ramps or Equivalent.

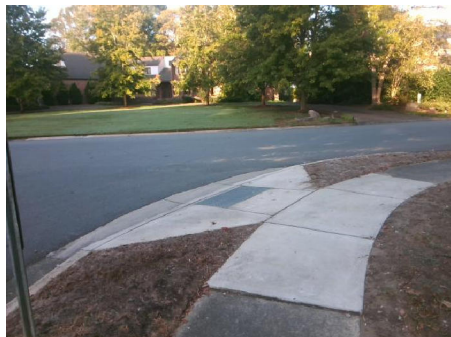
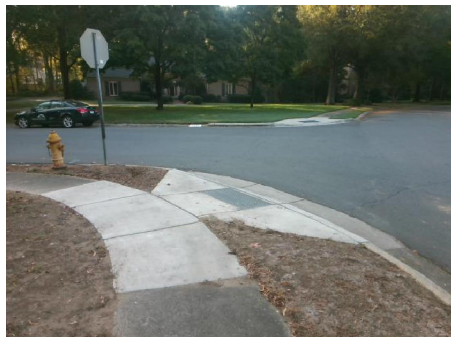
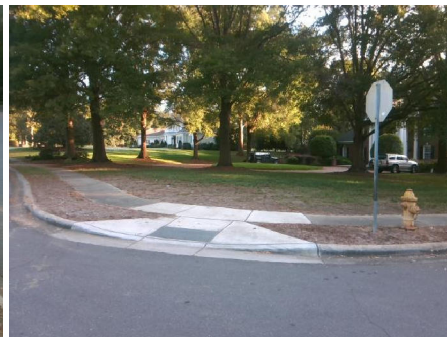
Street 1 Name	BALTUSROL LN
Stop Condition-Street 2	None
Street 2 Name	BALTUSROL LN
Stop Condition-Street 1	StopSign
