Access Compliance Report

Public Rights-of-Way

(Curb Ramps)

Intersection ID: N/A	Main Street: TUCKASEEGEE_RD	Cross Street: N/A	Location: W
ADA ID: A605251DC0A8	Ramp Type: Perp	Initial Pass/Fail: Fail	Overall Compliance: No
		Severity Score: 35

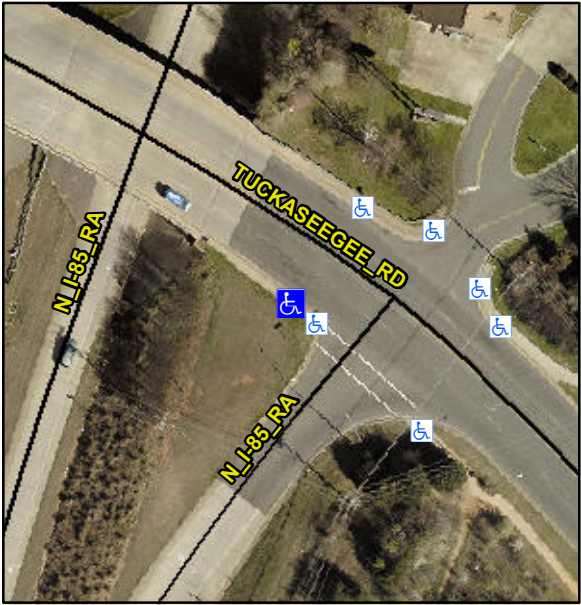
Possible Solutions:		Compliance	Description	Data
	Remove & Replace Entire Ramp.		N/A	Ramp Length (in)	54.0
			No	Ramp Width (in)	41.0
			N/A	Flare Type LT	N/A
			N/A	Flare Slope LT (%)	N/A
			N/A	Flare Traversable LT?	No
			N/A	Landing Length (in)	N/A
			N/A	Landing Width (in)	N/A
			N/A	Landing Slope (%)	N/A
			N/A	Landing X Slope (%)	N/A
<p>Surveyor Notes:</p> <p>N/A</p> <p>PROW/ADA:</p> <p>Not Found, R304.5.1, R304.2.2</p>			N/A	Flare Type RT	N/A
			N/A	Flare Slope RT (%)	N/A
			N/A	Flare Traversable RT?	No
			N/A	DWS Provided?	N/A
			N/A	DWS Contrast?	N/A
			N/A	DWS Length (in)	N/A
			N/A	DWS Full Width?	N/A
			N/A	DWS Offset (in)	N/A
			N/A	Gutter Ponding?	N/A
			N/A	Gutter Lip Ht (in)	N/A
			N/A	Painted X Walk1?	No
				X Walk 1 Direction	To NE
			N/A	X Walk 1 Width (in)	N/A
				X Walk 1 Slope (%)	3.9
				X Walk 1 X Slope (%)	2.7
