Access Compliance Report Public Rights-of-Way (Curb Ramps)

Intersection ID: 43361 Main Street: PROSPERITY COMMONS DR Cross Street: RIDGEVIEW COMMONS DR Location: SW ADA ID: A60B27EB9021 Ramp Type: BlendTrans1 Initial Pass/Fail: Fail **Overall Compliance: No Severity Score:** 12.5

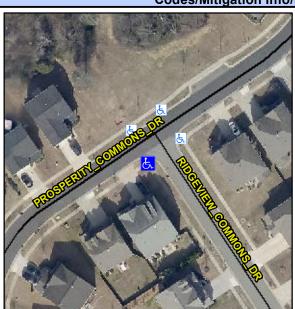
Comp	Compliance Description		Compliance Description		Data
N/A	Ramp Length (in)	71.5	Yes	BlendTrans Slope (%)	4.3
Yes	Ramp Width (in)	48.0	No	BlendTrans XSlope (%)	5.8
N/A	Flare Type LT	N/A	N/A	Flare Type RT	N/A
N/A	Flare Slope LT (%)	N/A	N/A	Flare Slope RT (%)	N/A
N/A	Flare Traversable LT?	N/A	N/A	Flare Traversable RT?	N/A
N/A	Landing Length (in)	N/A	N/A	DWS Provided?	N/A
N/A	Landing Width (in)	N/A	N/A	DWS Contrast?	N/A
N/A	Landing Slope (%)	N/A	N/A	DWS Length (in)	N/A
N/A	Landing X Slope (%)	N/A	N/A	DWS Full Width?	N/A
N/A	Landing Curb? (Y/N)	N/A	N/A	DWS Offset (in)	N/A
N/A	Shared Landing?	N/A			
N/A	Gutter Ponding?	N/A	N/A	Gutter Slope (%)	N/A
N/A	Gutter Lip Ht (in)	N/A	N/A	Gutter X Slope (%)	N/A
N/A	Painted X Walk1?	No	N/A	Painted X Walk2?	No
	X Walk 1 Direction	То Е		X Walk 2 Direction	To N
	X Walk 1 Width (in)	N/A		X Walk 2 Width (in)	N/A
	X Walk 1 Slope (%)	3.9		X Walk 2 Slope (%)	4.0
	X Walk 1 X Slope (%)	0.1		X Walk 2 X Slope (%)	2.9

N/A	Ramp inside XWalk1?	N/A	N/A	Ramp inside XWalk2?	N/A
	Road Slope (%)	2.8		Clear Space?	N/A
	Road X Slope (%)	4.5	N/A	Clear Space to XWalk (in)	N/A
N/A	Any Obstructions?	N/A	N/A	Storm Grate/Utility Hazard?	N/A
	Obstruction Type			Storm Grate/Utility Type	
		N/A			N/A
			Yes	Surface Condition? (G/P)	Good
			No	Curb Slope (%)	14.2

Possible Solutions: Remove & Replace Curb Ramp With **Two New Directional Ramps or** Equivalent. Surveyor Notes: N/A
