Access Compliance Report

Public Rights-of-Way

(Curb Ramps)

Intersection ID: 43641	Main Street: HUNTINGTON_MEADOW_LN	Cross Street: KENDRICK_CROSS_RD	Location: SW
ADA ID: A60B4B7165CF	Ramp Type: PerpDiag	Initial Pass/Fail: Fail	Overall Compliance: No
Severity Score: 22.5			
Codes/Mitigation Info/Possible Solution		Field Measurements/Component Compliance

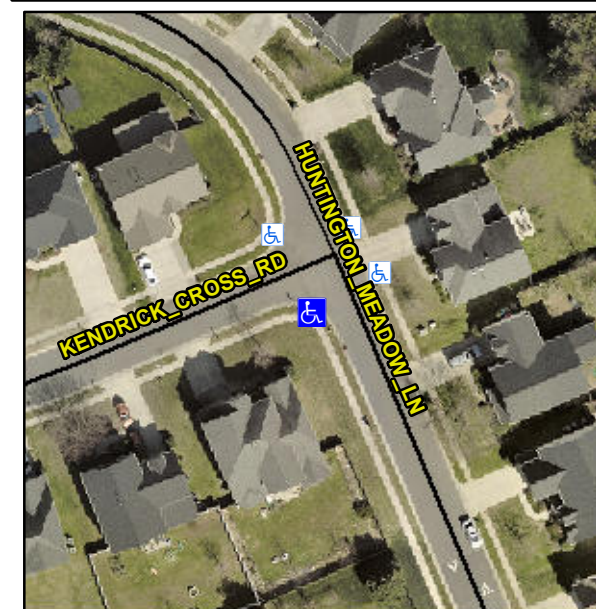
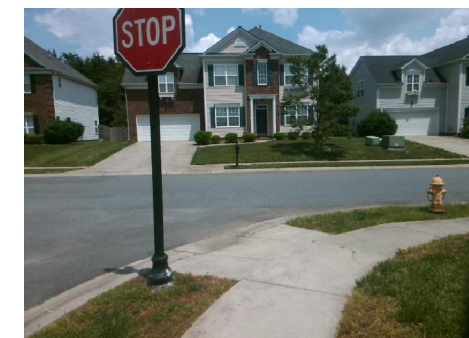
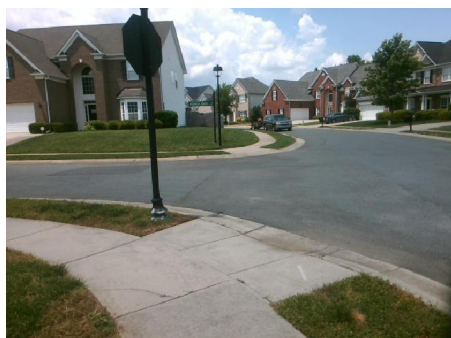
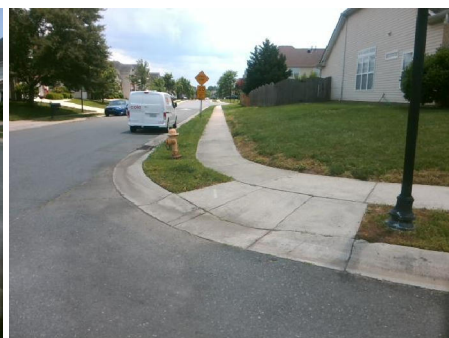
Compliance	Description	Data	Compliance	Description	Data
N/A	Ramp Length (in)	50.0	No	Ramp Slope (%)	10.8
No	Ramp Width (in)	36.0	No	Ramp XSlope (%)	3.3
N/A	Flare Type LT	N/A	N/A	Flare Type RT	N/A
N/A	Flare Slope LT (%)	N/A	N/A	Flare Slope RT (%)	N/A
N/A	Flare Traversable LT?	N/A	N/A	Flare Traversable RT?	N/A
N/A	Landing Length (in)	N/A	N/A	DWS Provided?	N/A
N/A	Landing Width (in)	N/A	N/A	DWS Contrast?	N/A
N/A	Landing Slope (%)	N/A	N/A	DWS Length (in)	N/A
N/A	Landing X Slope (%)	N/A	N/A	DWS Full Width?	N/A
N/A	Landing Curb? (Y/N)	N/A	N/A	DWS Offset (in)	N/A
N/A	Shared Landing?	N/A			
N/A	Gutter Ponding?	N/A	N/A	Gutter Slope (%)	N/A
N/A	Gutter Lip Ht (in)	N/A	N/A	Gutter X Slope (%)	N/A
N/A	Painted X Walk1?	No	N/A	Painted X Walk2?	No
	X Walk 1 Direction	To E		X Walk 2 Direction	To N
N/A	X Walk 1 Width (in)	N/A	N/A	X Walk 2 Width (in)	N/A
	X Walk 1 Slope (%)	4.0		X Walk 2 Slope (%)	3.5
	X Walk 1 X Slope (%)	1.5		X Walk 2 X Slope (%)	0.8

N/A	Ramp inside XWalk1?	N/A	N/A	Ramp inside XWalk2?	N/A
	Road Slope (%)	2.0	N/A	Clear Space?	N/A
	Road X Slope (%)	0.4	N/A	Clear Space to XWalk (in)	N/A
N/A	Any Obstructions?	N/A	N/A	Storm Grate/Utility Hazard?	N/A
	Obstruction Type			Storm Grate/Utility Type	
		N/A			N/A
			Yes	Surface Condition? (G/P)	Good

Remove & Replace Curb Ramp With Two New Directional Ramps or Equivalent.

R304.5.1, R304.2.2, R304.5.3
