# Access Compliance Report

## Public Rights-of-Way

### (Curb Ramps)

| Intersection ID: 48942 | Main Street: MITCHELL_GRANT_WY | Cross Street: MORGAN_LEE_AV | Location: E |

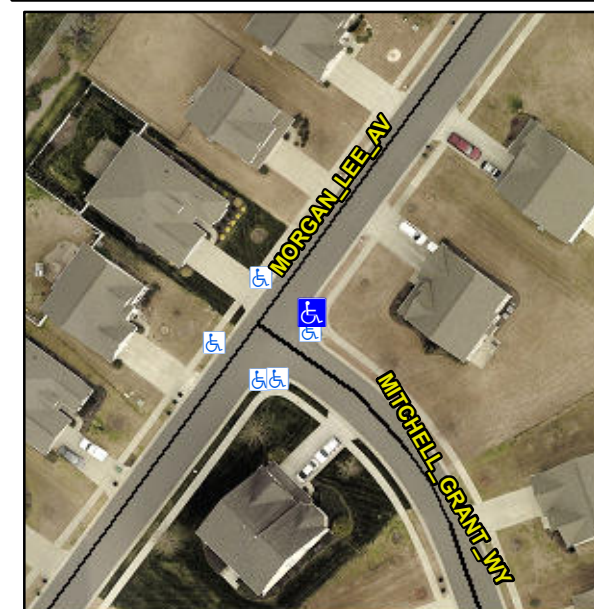
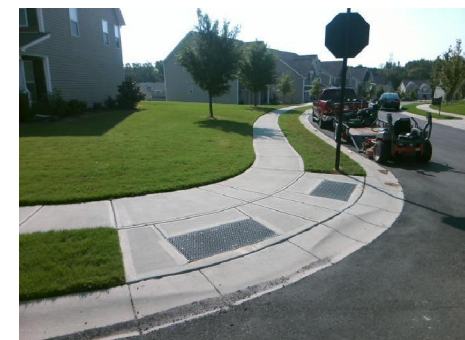
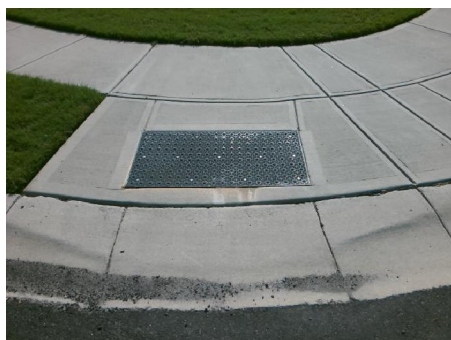
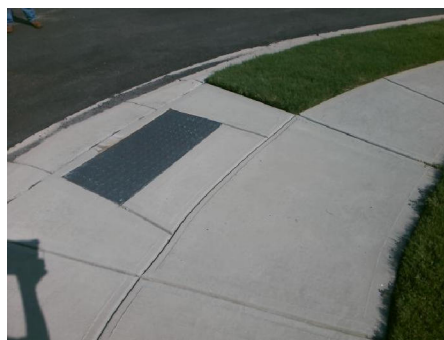
**CURB GAP 1.0, CURB WIDTH 46.0**

**Not Found, R304.5.1**

| Compliance | Description | Data | Compliance | Description | Data |
|---|---|---|---|---|---|
| No | Ramp Width (in) | 47.0 | Yes | BlendTrans XSlope (%) | 1.0 |
| | | | No | Curb Slope (%) | 14.3 |

**Remove & Replace Curb Ramp With Two New Directional Ramps or Equivalent.**
