Access Compliance Report Public Rights-of-Way (Curb Ramps)

Intersection ID: 19937 Main Street: S TRYON ST **Cross Street: THORNFIELD RD** Location: NE ADA ID: A6160B96AEFE Ramp Type: PerpDiag Initial Pass/Fail: Pass **Overall Compliance: No Severity Score:** 5.25

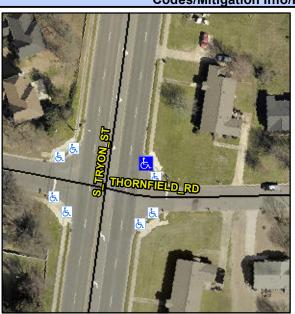
| Field Measurements/Component Compliance | |
|---|---|
| Yes Ramp Width (in) 48.0 No Ramp XSlope | : (%) 3.2 |
| Yes Gutter Ponding? No No Gutter Slope | (%) 5.5 |
| Yes Gutter Lip Ht (in) 0.0 No Gutter X Slop | e (%) 5.1 |

Possible Solutions: Remove & Replace Curb Ramp With **Two New Directional Ramps or** Equivalent. Remove & Replace Gutter. Surveyor Notes: N/A PROW/ADA: Not Found, R304.5.3, R304.5.4
