# Access Compliance Report

## Public Rights-of-Way

### (Curb Ramps)

Intersection ID: 7556	Main Street: GEORGETOWN_DR	Cross Street: MONTEITH_DR	Location: SW
ADA ID: A61D19EF72F6	Ramp Type: Perp	Initial Pass/Fail: Fail	Overall Compliance: No
Severity Score: 8.75			
Codes/Mitigation Info/Possible Solution		Field Measurements/Component Compliance

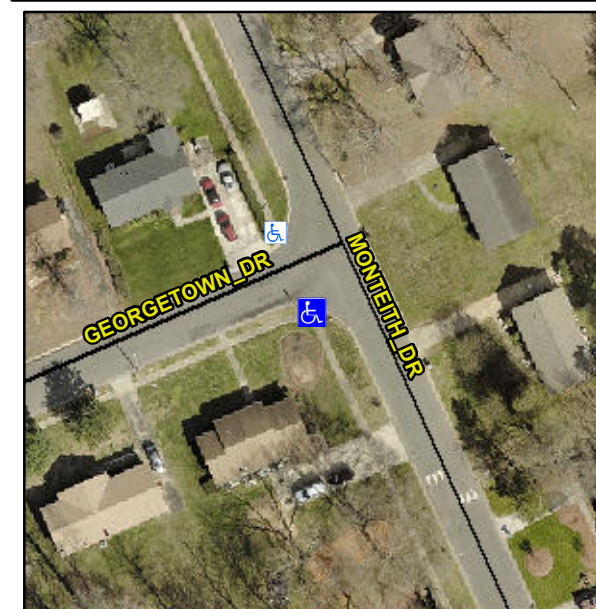
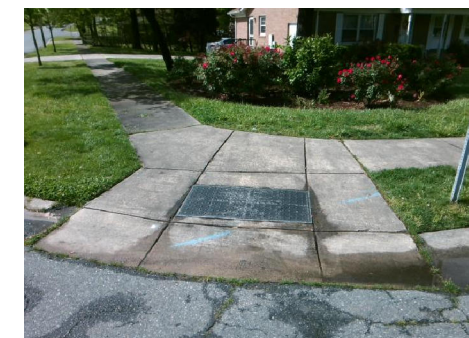
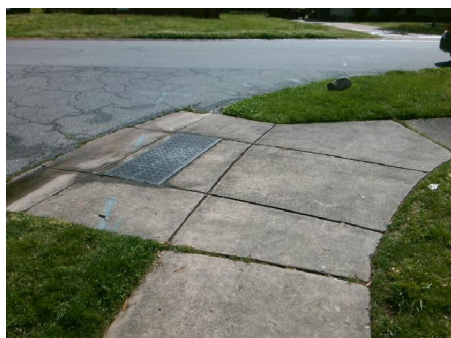
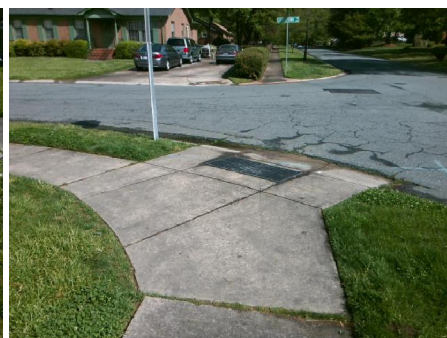
Compliance	Description	Data	Compliance	Description	Data
N/A	Ramp Length (in)	44.0	Yes	Ramp Slope (%)	6.7
No	Ramp Width (in)	46.0	Yes	Ramp XSlope (%)	1.0
N/A	Flare Type LT	N/A	N/A	Flare Type RT	N/A
N/A	Flare Slope LT (%)	N/A	N/A	Flare Slope RT (%)	N/A
N/A	Flare Traversable LT?	N/A	N/A	Flare Traversable RT?	N/A
N/A	Landing Length (in)	N/A	N/A	DWS Provided?	N/A
N/A	Landing Width (in)	N/A	N/A	DWS Contrast?	N/A
N/A	Landing Slope (%)	N/A	N/A	DWS Length (in)	N/A
N/A	Landing X Slope (%)	N/A	N/A	DWS Full Width?	N/A
N/A	Landing Curb? (Y/N)	N/A	N/A	DWS Offset (in)	N/A
N/A	Shared Landing?	N/A			
N/A	Gutter Ponding?	N/A	N/A	Gutter Slope (%)	N/A
N/A	Gutter Lip Ht (in)	N/A	N/A	Gutter X Slope (%)	N/A
N/A	Painted X Walk1?	No	N/A	Painted X Walk2?	N/A
	X Walk 1 Direction	To N		X Walk 2 Direction	N/A
N/A	X Walk 1 Width (in)	N/A	N/A	X Walk 2 Width (in)	N/A
	X Walk 1 Slope (%)	4.6		X Walk 2 Slope (%)	N/A
	X Walk 1 X Slope (%)	1.2		X Walk 2 X Slope (%)	N/A

N/A	Ramp inside XWalk1?	N/A	N/A	Ramp inside XWalk2?	N/A
	Road Slope (%)	N/A	N/A	Clear Space?	N/A
	Road X Slope (%)	N/A	N/A	Clear Space to XWalk (in)	N/A
N/A	Any Obstructions?	N/A	N/A	Storm Grate/Utility Hazard?	N/A
	Obstruction Type			Storm Grate/Utility Type	
		N/A			N/A
		Yes		Surface Condition? (G/P)	Good

Possible Solutions:

**Remove & Replace Entire Ramp.**

**Not Found, R304.5.1**
