# Access Compliance Report

## Public Rights-of-Way

### (Curb Ramps)

| Intersection ID: 13702 | Main Street: CENTRAL_AV | Cross Street: MERRY_OAKS_RD | Location: NE |

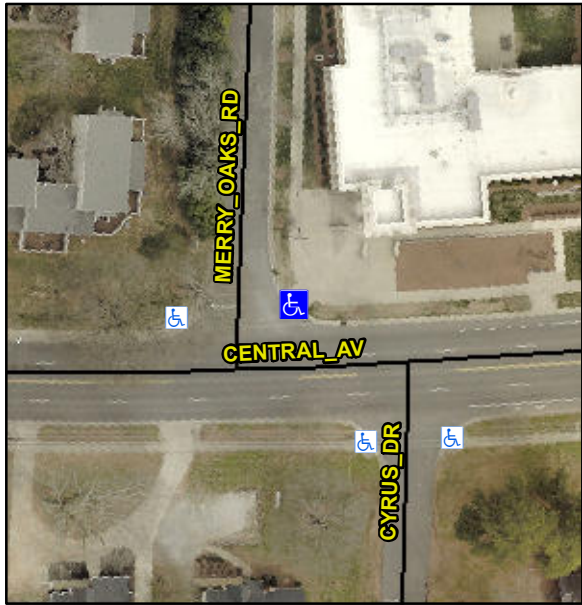
| ADA ID: A64BD39BED72 | Ramp Type: Perp | Initial Pass/Fail: Fail | Overall Compliance: No |

| Codes/Mitigation Info/Possible Solution | | | Field Measurements/Component Compliance | | | | | | |
|---|---|---|---|---|---|---|---|---|--|
| | | | No | Ramp Width (in) | 46.0 | Yes | Ramp XSlope (%) | 0.7 | |
| | PROW/ADA: | | Not Found, R304.5.1 | | N/A | Shared Landing? | N/A | | |

| Codes/Mitigation Info/Possible Solution | | | Field Measurements/Component Compliance | | | | | | |
|---|---|---|---|---|---|---|---|---|--|
| | Remove & Replace Entire Ramp. | | N/A | Ramp Length (in) | 95.0 | Yes | Ramp Slope (%) | 5.1 | |
| | | Total Cost: | \$ | 1850.00 | | | | | |
