Access Compliance Report

Public Rights-of-Way

(Curb Ramps)

Intersection ID: 13168	Main Street: CENTRAL_AV	Cross Street: NANDINA_ST	Location: NE
ADA ID: A64EA7A92B8D	Ramp Type: PerpDiag	Initial Pass/Fail: Fail	Overall Compliance: No
		Severity Score: 10

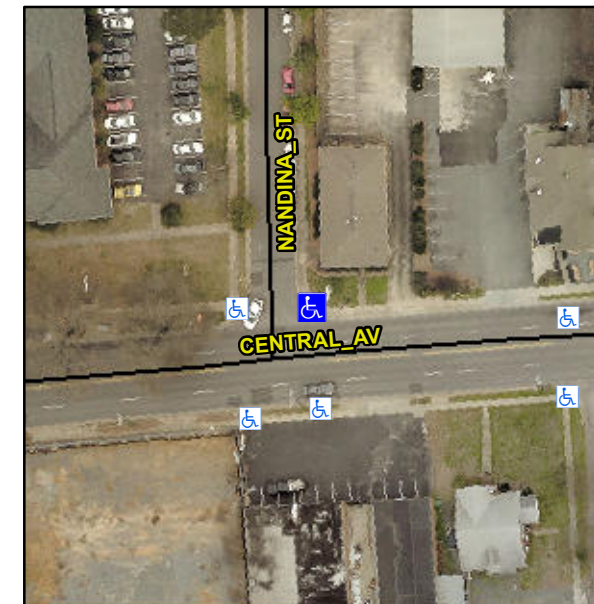
Not Found, R304.5.1, R304.5.3

Compliance	Description	Data	Compliance	Description	Data
N/A	Ramp Length (in)	55.0	Yes	Ramp Slope (%)	7.3
No	Ramp Width (in)	38.0	No	Ramp XSlope (%)	3.1
N/A	Flare Type LT	N/A	N/A	Flare Type RT	N/A
N/A	Flare Slope LT (%)	N/A	N/A	Flare Slope RT (%)	N/A
N/A	Flare Traversable LT?	N/A	N/A	Flare Traversable RT?	N/A
N/A	Landing Length (in)	N/A	N/A	DWS Provided?	N/A
N/A	Landing Width (in)	N/A	N/A	DWS Contrast?	N/A
N/A	Landing Slope (%)	N/A	N/A	DWS Length (in)	N/A
N/A	Landing X Slope (%)	N/A	N/A	DWS Full Width?	N/A
N/A	Landing Curb? (Y/N)	N/A	N/A	DWS Offset (in)	N/A
N/A	Shared Landing?	N/A			
N/A	Gutter Ponding?	N/A	N/A	Gutter Slope (%)	N/A
N/A	Gutter Lip Ht (in)	N/A	N/A	Gutter X Slope (%)	N/A
N/A	Painted X Walk1?	No	N/A	Painted X Walk2?	No
	X Walk 1 Direction	To W		X Walk 2 Direction	To S
N/A	X Walk 1 Width (in)	N/A	N/A	X Walk 2 Width (in)	N/A
	X Walk 1 Slope (%)	4.2		X Walk 2 Slope (%)	8.4
	X Walk 1 X Slope (%)	4.8		X Walk 2 X Slope (%)	4.5

N/A	Ramp inside XWalk1?	N/A	N/A	Ramp inside XWalk2?	N/A
	Road Slope (%)	3.2	N/A	Clear Space?	N/A
	Road X Slope (%)	7.1	N/A	Clear Space to XWalk (in)	N/A
N/A	Any Obstructions?	N/A	N/A	Storm Grate/Utility Hazard?	N/A
	Obstruction Type			Storm Grate/Utility Type	
		N/A			N/A
			Yes	Surface Condition? (G/P)	Good

Remove & Replace Curb Ramp With Two New Directional Ramps or Equivalent.
