Access Compliance Report

Public Rights-of-Way

(Curb Ramps)

Intersection ID: 31581	Main Street: BLYTHEDALE_DR	Cross Street: PATTONSBURG_DR	Location: SE
ADA ID: A658E1626D4C	Ramp Type: BlendTrans1	Initial Pass/Fail: Fail	Overall Compliance: No
Severity Score: 8.75			
Codes/Mitigation Info/Possible Solution		Field Measurements/Component Compliance

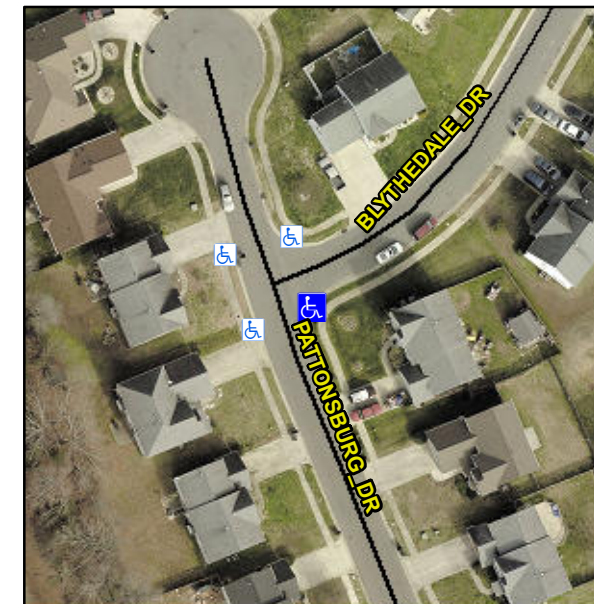
DWS DETACHED

Not Found, R304.5.1

Compliance	Description	Data	Compliance	Description	Data
N/A	Ramp Length (in)	49.0	Yes	BlendTrans Slope (%)	3.5
No	Ramp Width (in)	44.0	Yes	BlendTrans XSlope (%)	0.7
N/A	Flare Type LT	N/A	N/A	Flare Type RT	N/A
N/A	Flare Slope LT (%)	N/A	N/A	Flare Slope RT (%)	N/A
N/A	Flare Traversable LT?	N/A	N/A	Flare Traversable RT?	N/A
N/A	Landing Length (in)	N/A	N/A	DWS Provided?	N/A
N/A	Landing Width (in)	N/A	N/A	DWS Contrast?	N/A
N/A	Landing Slope (%)	N/A	N/A	DWS Length (in)	N/A
N/A	Landing X Slope (%)	N/A	N/A	DWS Full Width?	N/A
N/A	Landing Curb? (Y/N)	N/A	N/A	DWS Offset (in)	N/A
N/A	Shared Landing?	N/A			
N/A	Gutter Ponding?	N/A	N/A	Gutter Slope (%)	N/A
N/A	Gutter Lip Ht (in)	N/A	N/A	Gutter X Slope (%)	N/A
N/A	Painted X Walk1?	No	N/A	Painted X Walk2?	No
	X Walk 1 Direction	To N		X Walk 2 Direction	To W
	X Walk 1 Width (in)	N/A		X Walk 2 Width (in)	N/A
	X Walk 1 Slope (%)	3.0		X Walk 2 Slope (%)	2.9
	X Walk 1 X Slope (%)	1.1		X Walk 2 X Slope (%)	3.3

N/A	Ramp inside XWalk1?	N/A	N/A	Ramp inside XWalk2?	N/A
	Road Slope (%)	2.0		Clear Space?	N/A
	Road X Slope (%)	5.6	N/A	Clear Space to XWalk (in)	N/A
N/A	Any Obstructions?	N/A	N/A	Storm Grate/Utility Hazard?	N/A
	Obstruction Type			Storm Grate/Utility Type	
		N/A			N/A
			Yes	Surface Condition? (G/P)	Good
			No	Curb Slope (%)	25.6

Possible Solutions:

Remove & Replace Curb Ramp With Two New Directional Ramps or Equivalent.

Total Cost: \$ 3200.00
