Access Compliance Report

Public Rights-of-Way

(Curb Ramps)

| Intersection ID: 47159 | Main Street: TODDVILLE_RD | Cross Street: SUMMEROUR_PL | Location: | N |

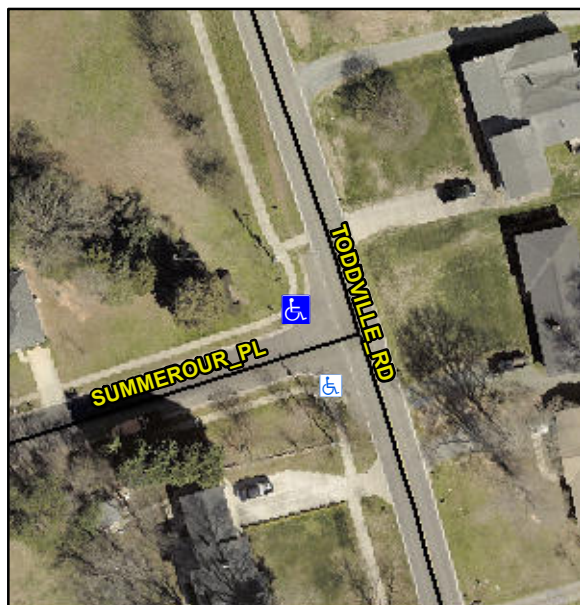
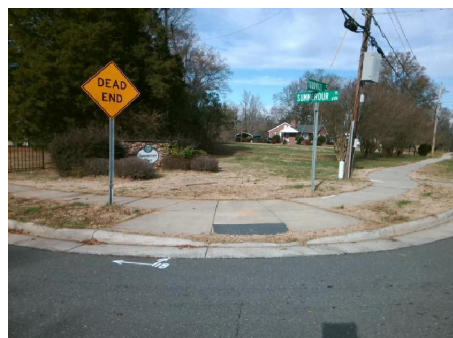
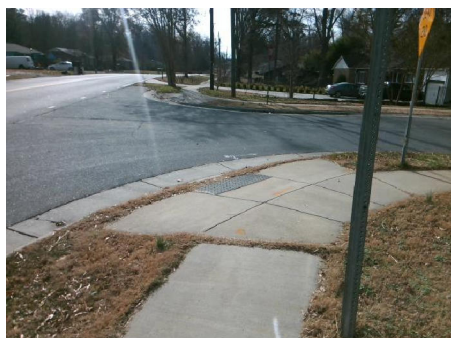
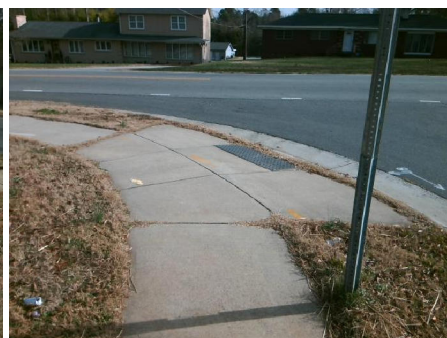
| ADA ID: A65A50F49702 | Ramp Type: Perp | Initial Pass/Fail: Fail | Overall Compliance: No | Severity Score: 22.5 |

Not Found, R304.5.1, R304.2.2, R304.5.3

| Compliance | Description | Data | Compliance | Description | Data |
|---|---|---|---|---|---|
| N/A | Ramp Length (in) | 53.0 | No | Ramp Slope (%) | 11.7 |
| No | Ramp Width (in) | 41.5 | No | Ramp XSlope (%) | 2.3 |

Remove & Replace Entire Ramp.
