Access Compliance Report

Public Rights-of-Way

(Curb Ramps)

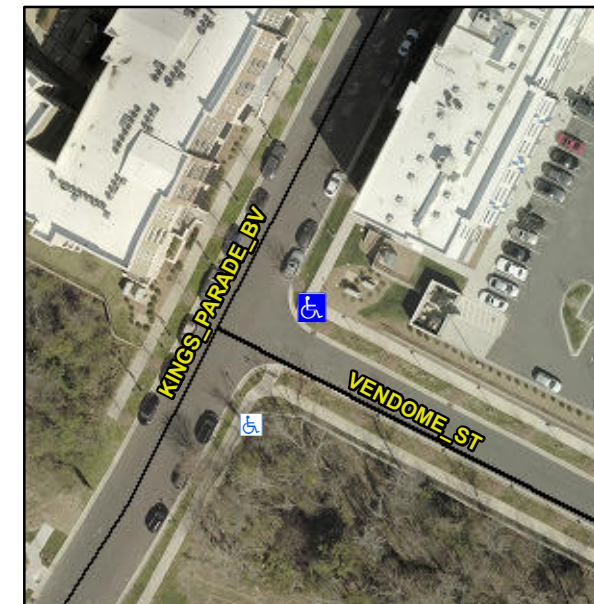
Intersection ID: 44785	Main Street: KINGS_PARADE_BV	Cross Street: VENDOME_ST	Location: NE
ADA ID: A66AD6F145CE	Ramp Type: Directional1	Initial Pass/Fail: Fail	Overall Compliance: No
Severity Score: 1.25			
Codes/Mitigation Info/Possible Solution		Field Measurements/Component Compliance

Compliance	Description	Data	Compliance	Description	Data
N/A	Ramp Length (in)	78.0	N/A	Grade Break?	N/A
Yes	Ramp Width (in)	72.0	N/A	Grade Break Slope (%)	0.0
Yes	Ramp Slope (%)	3.5	N/A	Grade Break XSlope (%)	0.0
No	Ramp XSlope (%)	3.3			
N/A	Flare Type LT	N/A	N/A	Flare Type RT	N/A
N/A	Flare Slope LT (%)	N/A	N/A	Flare Slope RT (%)	0.0
N/A	Flare Traversable LT?	N/A	N/A	Flare Traversable RT?	N/A
N/A	Landing Length (in)	0.0	N/A	DWS Provided?	N/A
N/A	Landing Width (in)	0.0	N/A	DWS Contrast?	N/A
N/A	Landing Slope (%)	0.0	N/A	DWS Length (in)	N/A
N/A	Landing X Slope (%)	0.0	N/A	DWS Full Width?	N/A
N/A	Landing Curb? (Y/N)	N/A	N/A	DWS Offset LT (in)	N/A
N/A	Shared Landing?	N/A	N/A	DWS Offset RT (in)	N/A
N/A	Gutter Ponding?	0.0	N/A	Gutter Slope (%)	N/A
N/A	Gutter Lip Ht (in)	0.0	N/A	Gutter X Slope (%)	N/A
N/A	Painted X Walk1?	No		Road Slope (%)	1.1
	X Walk 1 Direction	To SW		Road X Slope (%)	1.4
	X Walk 1 Width (in)	N/A		Clear Space?	N/A

X Walk 1 Slope (%)	1.1	N/A	Clear Space to XWalk (in)	N/A
	X Walk 1 X Slope (%)	1.4	N/A	Storm Grate/Utility Hazard?	N/A
N/A	Ramp inside XWalk1?	N/A		Storm Grate/Utility Type	
N/A	Any Obstructions?	N/A			N/A
	Obstruction Type		Yes	Surface Condition? (G/P)	Good
			N/A	Curb Slope (%)	13.0

Possible Solutions:

Remove & Replace Entire Ramp.
