# Access Compliance Report

## Public Rights-of-Way

| Intersection ID: 10026441 | Main Street: FARMHURST_DR | Cross Street: N/A | Location: NW |
| ADA ID: A66B82459B21 | Ramp Type: PerpDiag | Initial Pass/Fail: Fail | Overall Compliance: No |

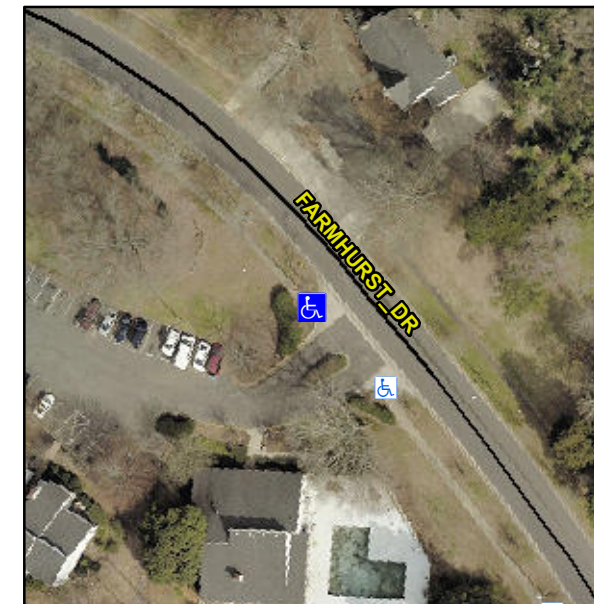
| | | Severity Score: 35 | |

**Not Found, R304.5.1, R304.2.2**

| Compliance | Description | Data | Compliance | Description | Data |
|---|---|---|---|---|---|
| N/A | Ramp Length (in) | 67.0 | No | Ramp Slope (%) | 12.2 |
| No | Ramp Width (in) | 44.0 | Yes | Ramp XSlope (%) | 4.8 |

**Remove & Replace Curb Ramp With Two New Directional Ramps or Equivalent.**

Total Cost: \$ 3200.00
