Access Compliance Report

Public Rights-of-Way

(Curb Ramps)

| Intersection ID: 43028 | Main Street: BIG_BEAR_DR | Cross Street: AUTUMN_GOLD_CT | Location: SW |

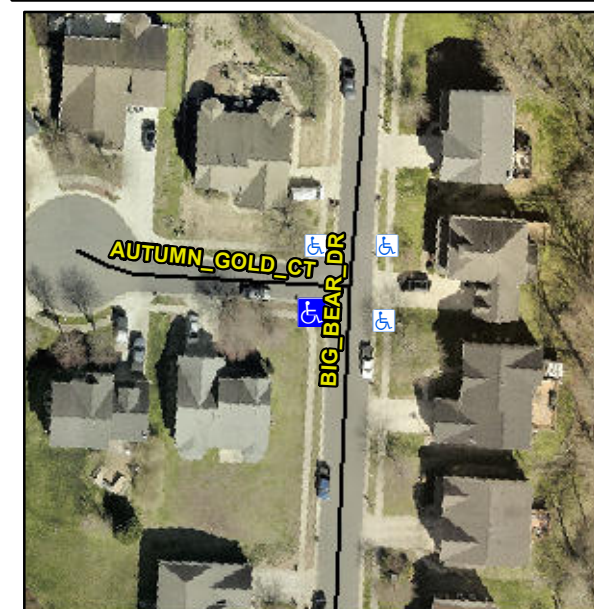
Not Found, R304.5.1

| Compliance | Description | Data | Compliance | Description | Data |
|---|---|---|---|---|---|
| No | Ramp Width (in) | 36.0 | Yes | Ramp XSlope (%) | 1.8 |

Remove & Replace Curb Ramp With Two New Directional Ramps or Equivalent.
