## Access Compliance Report Public Rights-of-Way (Curb Ramps)

Intersection ID: 14659 Main Street: E\_WORTHINGTON\_AV Cross Street: SPRINGDALE\_AV Location: W

ADA ID: A68B34B01722 Ramp Type: Perp Initial Pass/Fail: Fail Overall Compliance: No Severity Score: 13.75

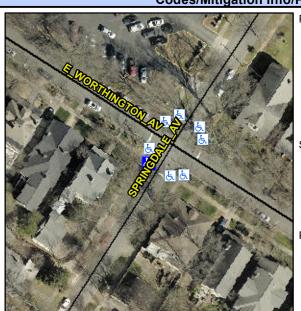
Compliance Description Data Compliance Description No N/A Ramp Length (in) 108.0 Ramp Slope (%) No Ramp XSlope (%) Yes Ramp Width (in) 54.0 N/A N/A Flare Type LT N/A Flare Type RT N/A N/A N/A Flare Slope RT (%) Flare Slope LT (%) N/A Flare Traversable LT? N/A N/A Flare Traversable RT? N/A N/A N/A DWS Provided? Landing Length (in) N/A Landing Width (in) N/A N/A **DWS Contrast?** N/A N/A N/A Landing Slope (%) DWS Length (in) N/A Landing X Slope (%) N/A N/A DWS Full Width? N/A Landing Curb? (Y/N) N/A N/A DWS Offset (in) N/A N/A Shared Landing? N/A **Gutter Ponding?** N/A N/A Gutter Slope (%) N/A Gutter Lip Ht (in) N/A N/A Gutter X Slope (%) N/A Painted X Walk1? No N/A Painted X Walk2? X Walk 1 Direction To SE X Walk 2 Direction N/A N/A X Walk 1 Width (in) X Walk 2 Width (in) X Walk 1 Slope (%) 4.1 X Walk 2 Slope (%) X Walk 1 X Slope (%) 4.0 X Walk 2 X Slope (%) N/A N/A N/A Ramp inside XWalk2? Ramp inside XWalk1? Road Slope (%) N/A N/A Clear Space? N/A Road X Slope (%) N/A Clear Space to XWalk (in) N/A N/A Any Obstructions? N/A Storm Grate/Utility Hazard?

Possible Solutions:

Remove & Replace Entire Ramp.

R304.2.2, R304.5.3
