## Access Compliance Report Public Rights-of-Way (Curb Ramps)

Intersection ID: 43592Main Street:DAVID\_TAYLOR\_DRCross Street: ANDREW\_CARNEGIE\_BVLocation:SEADA ID: A68C1E40BF31Ramp Type:ParaInitial Pass/Fail:FailOverall Compliance:NoSeverity Score:25

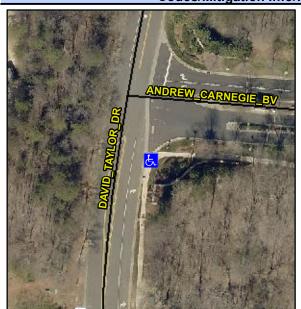
RT RP < 5%

R304.3.2

Comp	liance Description	nent Compliance	Data		
N/A	Ramp Length LT (in)	<u>Data</u> 50.5	N/A	Ramp Length RT (in)	46.5
Yes	Ramp Width LT (in)	75.0	Yes	Ramp Width RT (in)	71.0
No	Ramp Slope LT (%)	18.5	Yes	Ramp Slope RT (%)	3.1
Yes	Ramp XSlope LT (%)	1.4	Yes	Ramp XSlope RT (%)	0.6
N/A	Landing Length (in)	N/A	N/A	DWS Provided?	N/A
N/A	Landing Width (in)	N/A	N/A	DWS Contrast?	N/A
N/A	Landing Slope (%)	N/A	N/A	DWS Length (in)	N/A
N/A	Landing X Slope (%)	N/A	N/A	DWS Full Width?	N/A
N/A	Landing Curb? (Y/N)	N/A	N/A	DWS Offset (in)	N/A
N/A	Shared Landing?	N/A			
N/A	Gutter Ponding?	N/A	N/A	Gutter Slope (%)	N/A
N/A	Gutter Lip Ht (in)	N/A	N/A	Gutter X Slope (%)	N/A
N/A	Painted X Walk1?	No	N/A	Painted X Walk2?	N/A
	X Walk 1 Direction	To N		X Walk 2 Direction	N/A
N/A	X Walk 1 Width (in)	N/A	N/A	X Walk 2 Width (in)	N/A
	X Walk 1 Slope (%)	3.4		X Walk 2 Slope (%)	N/A
	X Walk 1 X Slope (%)	6.4		X Walk 2 X Slope (%)	N/A
N/A	Ramp inside XWalk1?	N/A	N/A	Ramp inside XWalk2?	N/A

Road Slope (%)	N/A	N/A	Clear Space?	N/A
	Road X Slope (%)	N/A	N/A	Clear Space to XWalk (in)	N/A
N/A	Any Obstructions?	N/A	N/A	Storm Grate/Utility Hazard?	N/A
	Obstruction Type			Storm Grate/Utility Type	
		N/A			N/A
			Yes	Surface Condition? (G/P)	Good
			N/A	Curb Slope (%)	N/A
No.

Remove & Replace Entire Ramp.
