Access Compliance Report Public Rights-of-Way (Curb Ramps)

Intersection ID: 10022556 Main Street: CARMEL COMMONS BV **Cross Street: N/A** Location:

Ramp Type: PerpDiag Initial Pass/Fail: Fail **Overall Compliance: No** Severity Score: 58.75 ADA ID: A6B1906EC295

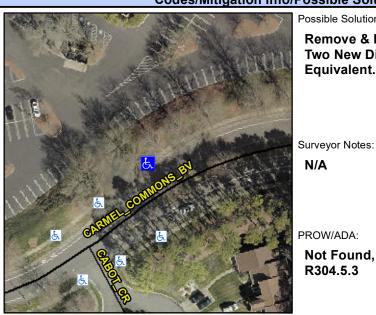
Not Found, R304.5.1, R304.2.2, R304.5.3

Compliance Description		Data	Compliance Description		Data
N/A	Ramp Length (in)	65.0	No	Ramp Slope (%)	17.1
No	Ramp Width (in)	43.0	No	Ramp XSlope (%)	8.0
N/A	Flare Type LT	N/A	N/A	Flare Type RT	N/A
N/A	Flare Slope LT (%)	N/A	N/A	Flare Slope RT (%)	N/A
N/A	Flare Traversable LT?	N/A	N/A	Flare Traversable RT?	N/A
N/A	Landing Length (in)	N/A	N/A	DWS Provided?	N/A
N/A	Landing Width (in)	N/A	N/A	DWS Contrast?	N/A
N/A	Landing Slope (%)	N/A	N/A	DWS Length (in)	N/A
N/A	Landing X Slope (%)	N/A	N/A	DWS Full Width?	N/A
N/A	Landing Curb? (Y/N)	N/A	N/A	DWS Offset (in)	N/A
N/A	Shared Landing?	N/A			
N/A	Gutter Ponding?	N/A	N/A	Gutter Slope (%)	N/A
N/A	Gutter Lip Ht (in)	N/A	N/A	Gutter X Slope (%)	N/A
N/A	Painted X Walk1?	No	N/A	Painted X Walk2?	No
	X Walk 1 Direction	To SW		X Walk 2 Direction	To S
N/A	X Walk 1 Width (in)	N/A	N/A	X Walk 2 Width (in)	N/A
	X Walk 1 Slope (%)	2.1		X Walk 2 Slope (%)	9.6
	X Walk 1 X Slope (%)	9.3		X Walk 2 X Slope (%)	1.4

N/A	Ramp inside XWalk1?	N/A	N/A	Ramp inside XWalk2?	N/A
	Road Slope (%)	8.0	N/A	Clear Space?	N/A
	Road X Slope (%)	5.3	N/A	Clear Space to XWalk (in)	N/A
N/A	Any Obstructions?	N/A	N/A	Storm Grate/Utility Hazard?	N/A
	Obstruction Type			Storm Grate/Utility Type	
		N/A			N/A
			Yes	Surface Condition? (G/P)	Good

Possible Solutions: Remove & Replace Curb Ramp With Two New Directional Ramps or Equivalent.
