Access Compliance Report

Public Rights-of-Way

(Curb Ramps)

Intersection ID: 23329	Main Street: GLENEAGLES_RD	Cross Street: PARK_RD	Location: SE
ADA ID: A6CB04018032	Ramp Type: Perp	Initial Pass/Fail: Fail	Overall Compliance: No
Codes/Mitigation Info/Possible Solution			Severity Score: 30
			Field Measurements/Component Compliance

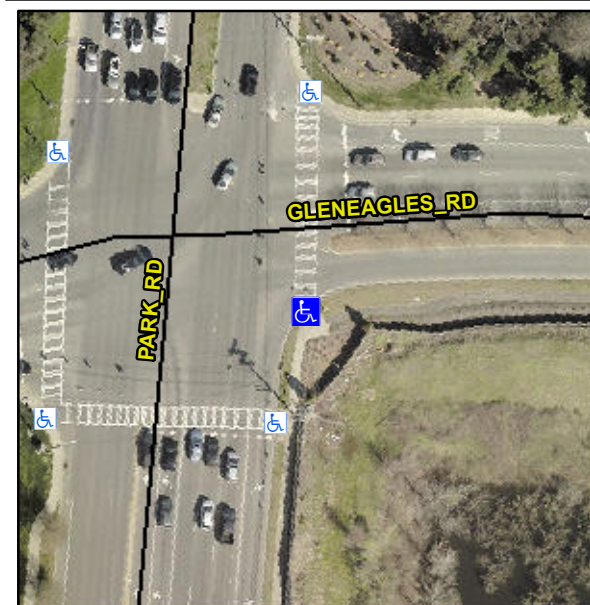
Not Found, R304.5.1, R304.2.2

Compliance	Description	Data	Compliance	Description	Data
N/A	Ramp Length (in)	67.0	No	Ramp Slope (%)	9.1
No	Ramp Width (in)	32.0	Yes	Ramp XSlope (%)	0.6
N/A	Flare Type LT	N/A	N/A	Flare Type RT	N/A
N/A	Flare Slope LT (%)	N/A	N/A	Flare Slope RT (%)	N/A
N/A	Flare Traversable LT?	N/A	N/A	Flare Traversable RT?	N/A
N/A	Landing Length (in)	N/A	N/A	DWS Provided?	N/A
N/A	Landing Width (in)	N/A	N/A	DWS Contrast?	N/A
N/A	Landing Slope (%)	N/A	N/A	DWS Length (in)	N/A
N/A	Landing X Slope (%)	N/A	N/A	DWS Full Width?	N/A
N/A	Landing Curb? (Y/N)	N/A	N/A	DWS Offset (in)	N/A
N/A	Shared Landing?	N/A			
N/A	Gutter Ponding?	N/A	N/A	Gutter Slope (%)	N/A
N/A	Gutter Lip Ht (in)	N/A	N/A	Gutter X Slope (%)	N/A
N/A	Painted X Walk1?	Yes	N/A	Painted X Walk2?	N/A
	X Walk 1 Direction	To N		X Walk 2 Direction	N/A
N/A	X Walk 1 Width (in)	119.0	N/A	X Walk 2 Width (in)	N/A
	X Walk 1 Slope (%)	0.4		X Walk 2 Slope (%)	N/A
	X Walk 1 X Slope (%)	1.5		X Walk 2 X Slope (%)	N/A

N/A	Ramp inside XWalk1?	Yes	N/A	Ramp inside XWalk2?	N/A
	Road Slope (%)	N/A	N/A	Clear Space?	N/A
	Road X Slope (%)	N/A	N/A	Clear Space to XWalk (in)	N/A
N/A	Any Obstructions?	N/A	N/A	Storm Grate/Utility Hazard?	N/A
	Obstruction Type			Storm Grate/Utility Type	
		N/A			N/A
			Yes	Surface Condition? (G/P)	Good

Remove & Replace Entire Ramp.
