Access Compliance Report

Public Rights-of-Way

(Curb Ramps)

Intersection ID: 22470	Main Street: SHARON_VIEW_RD	Cross Street: BENTRIDGE_DR	Location: SE
ADA ID: A6CBE45E3AA6	Ramp Type: PerpDiag	Initial Pass/Fail: Fail	Overall Compliance: No
Severity Score: 13.75			
Codes/Mitigation Info/Possible Solution		Field Measurements/Component Compliance

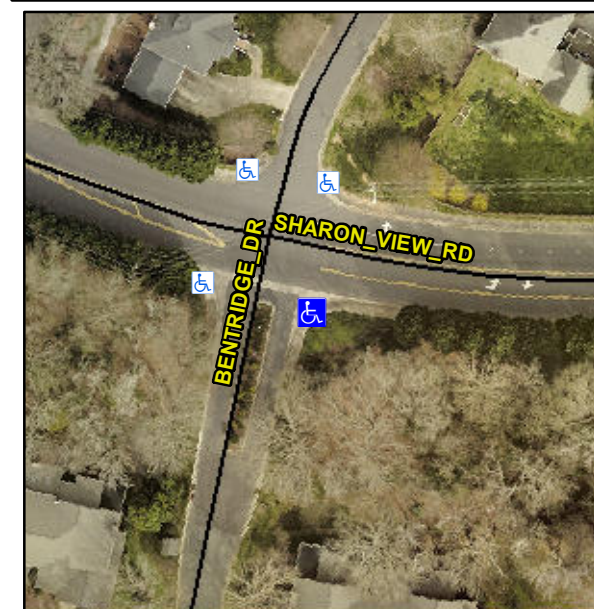
Not Found, R304.2.2, R304.5.3

Compliance	Description	Data	Compliance	Description	Data
N/A	Ramp Length (in)	60.5	No	Ramp Slope (%)	11.3
Yes	Ramp Width (in)	48.0	No	Ramp XSlope (%)	3.4
N/A	Flare Type LT	N/A	N/A	Flare Type RT	N/A
N/A	Flare Slope LT (%)	N/A	N/A	Flare Slope RT (%)	N/A
N/A	Flare Traversable LT?	N/A	N/A	Flare Traversable RT?	N/A
N/A	Landing Length (in)	N/A	N/A	DWS Provided?	N/A
N/A	Landing Width (in)	N/A	N/A	DWS Contrast?	N/A
N/A	Landing Slope (%)	N/A	N/A	DWS Length (in)	N/A
N/A	Landing X Slope (%)	N/A	N/A	DWS Full Width?	N/A
N/A	Landing Curb? (Y/N)	N/A	N/A	DWS Offset (in)	N/A
N/A	Shared Landing?	N/A			
N/A	Gutter Ponding?	N/A	N/A	Gutter Slope (%)	N/A
N/A	Gutter Lip Ht (in)	N/A	N/A	Gutter X Slope (%)	N/A
N/A	Painted X Walk1?	No	N/A	Painted X Walk2?	No
	X Walk 1 Direction	To N		X Walk 2 Direction	To NW
N/A	X Walk 1 Width (in)	N/A	N/A	X Walk 2 Width (in)	N/A
	X Walk 1 Slope (%)	0.1		X Walk 2 Slope (%)	5.0
	X Walk 1 X Slope (%)	5.3		X Walk 2 X Slope (%)	3.5

N/A	Ramp inside XWalk1?	N/A	N/A	Ramp inside XWalk2?	N/A
	Road Slope (%)	4.0	N/A	Clear Space?	N/A
	Road X Slope (%)	7.0	N/A	Clear Space to XWalk (in)	N/A
N/A	Any Obstructions?	N/A	N/A	Storm Grate/Utility Hazard?	N/A
	Obstruction Type			Storm Grate/Utility Type	
		N/A			N/A
		Yes		Surface Condition? (G/P)	Good

Possible Solutions:

Remove & Replace Curb Ramp With Two New Directional Ramps or Equivalent.
