Access Compliance Report Public Rights-of-Way (Curb Ramps)

Intersection ID: 20177 Main Street: FAIRVIEW_RD Cross Street: OGLUKIAN_RD Location: SE

ADA ID: A6CD08914EAD Ramp Type: BlendTrans2 Initial Pass/Fail: Fail Overall Compliance: No Severity Score: 12.5

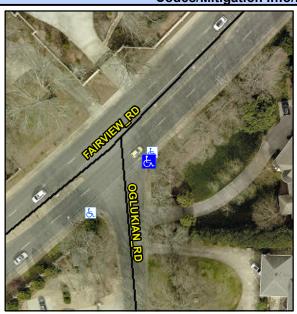
r leid Measurements/Component Compnance						
Compliance Description		Data	Data Compliance Description		Data	
N/A	Ramp Length (in)	60.0	Yes	BlendTrans Slope (%)	4.9	
Yes	Ramp Width (in)	48.0	No	BlendTrans XSlope (%)	6.8	
N/A	Flare Type LT	N/A	N/A	Flare Type RT	N/A	
N/A	Flare Slope LT (%)	N/A	N/A	Flare Slope RT (%)	N/A	
N/A	Flare Traversable LT?	N/A	N/A	Flare Traversable RT?	N/A	
N/A	Landing Length (in)	N/A	N/A	DWS Provided?	N/A	
N/A	Landing Width (in)	N/A	N/A	DWS Contrast?	N/A	
N/A	Landing Slope (%)	N/A	N/A	DWS Length (in)	N/A	
N/A	Landing X Slope (%)	N/A	N/A	DWS Full Width?	N/A	
N/A	Landing Curb? (Y/N)	N/A	N/A	DWS Offset (in)	N/A	
N/A	Shared Landing?	N/A				
N/A	Gutter Ponding?	N/A	N/A	Gutter Slope (%)	N/A	
N/A	Gutter Lip Ht (in)	N/A	N/A	Gutter X Slope (%)	N/A	
N/A	Painted X Walk1?	No	N/A	Painted X Walk2?	No	
	X Walk 1 Direction	To NW		X Walk 2 Direction	To SW	
	X Walk 1 Width (in)	N/A		X Walk 2 Width (in)	N/A

X Walk 1 Slope (%)	4.8		X Walk 2 Slope (%)	0.2	
	X Walk 1 X Slope (%)	0.5		X Walk 2 X Slope (%)	5.9	
N/A	Ramp inside XWalk1?	N/A	N/A	Ramp inside XWalk2?	N/A	
	Road Slope (%)	5.1		Clear Space?	N/A	
	Road X Slope (%)	2.9	N/A	Clear Space to XWalk (in)	N/A	
N/A	Any Obstructions?	N/A	N/A	Storm Grate/Utility Hazard?	N/A

FAIRVIEW RD None OGLUKIAN RD StopSign Possible Solutions:

Remove & Replace Curb Ramp With
Two New Directional Ramps or
Equivalent.

PROW/ADA:
Not Found, R304.5.3
