# Access Compliance Report

## Public Rights-of-Way

### (Curb Ramps)

Intersection ID: 10025384	Main Street: E_9TH_ST	Cross Street: N/A	Location: W
ADA ID: A6ED31B552E5	Ramp Type: PerpDiag	Initial Pass/Fail: Fail	Overall Compliance: No
Severity Score: 22.5			
Codes/Mitigation Info/Possible Solution		Field Measurements/Component Compliance

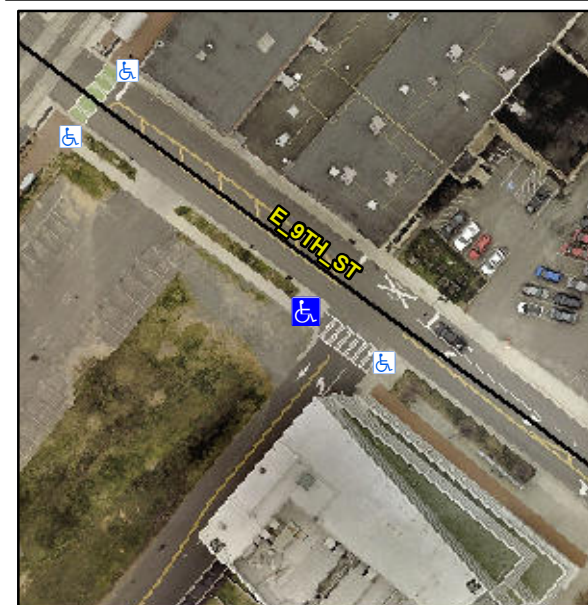
Compliance	Description	Data	Compliance	Description	Data
N/A	Ramp Length (in)	72.0	No	Ramp Slope (%)	10.5
No	Ramp Width (in)	46.5	No	Ramp XSlope (%)	2.3
N/A	Flare Type LT	N/A	N/A	Flare Type RT	N/A
N/A	Flare Slope LT (%)	N/A	N/A	Flare Slope RT (%)	N/A
N/A	Flare Traversable LT?	N/A	N/A	Flare Traversable RT?	N/A
N/A	Landing Length (in)	N/A	N/A	DWS Provided?	N/A
N/A	Landing Width (in)	N/A	N/A	DWS Contrast?	N/A
N/A	Landing Slope (%)	N/A	N/A	DWS Length (in)	N/A
N/A	Landing X Slope (%)	N/A	N/A	DWS Full Width?	N/A
N/A	Landing Curb? (Y/N)	N/A	N/A	DWS Offset (in)	N/A
N/A	Shared Landing?	N/A			
N/A	Gutter Ponding?	N/A	N/A	Gutter Slope (%)	N/A
N/A	Gutter Lip Ht (in)	N/A	N/A	Gutter X Slope (%)	N/A
N/A	Painted X Walk1?	Yes	N/A	Painted X Walk2?	No
	X Walk 1 Direction	To SE		X Walk 2 Direction	To NE
N/A	X Walk 1 Width (in)	143.0	N/A	X Walk 2 Width (in)	N/A
	X Walk 1 Slope (%)	2.4		X Walk 2 Slope (%)	0.3
	X Walk 1 X Slope (%)	2.3		X Walk 2 X Slope (%)	2.4

N/A	Ramp inside XWalk1?	Yes	N/A	Ramp inside XWalk2?	N/A
	Road Slope (%)	0.1	N/A	Clear Space?	N/A
	Road X Slope (%)	2.4	N/A	Clear Space to XWalk (in)	N/A
N/A	Any Obstructions?	N/A	N/A	Storm Grate/Utility Hazard?	N/A
	Obstruction Type			Storm Grate/Utility Type	
		N/A			N/A
			Yes	Surface Condition? (G/P)	Good

Possible Solutions:

**Remove & Replace Curb Ramp With Two New Directional Ramps or Equivalent.**

**R304.5.1, R304.2.2, R304.5.3**
