## **Access Compliance Report Public Rights-of-Way** (Curb Ramps)

Intersection ID: 14542 Main Street: DWIGHTWARE BV **Cross Street: GLADDEN CT** Location: SW **ADA ID: A6F2E253BC03** Ramp Type: Directional1 Initial Pass/Fail: Fail **Overall Compliance: No Severity Score:** 12.5

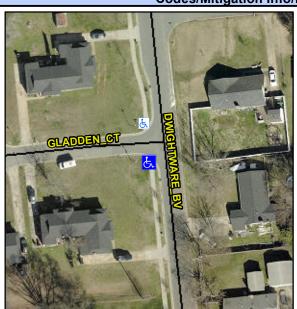
Yes	Ramp Width (in)
	No	Ramp Slope (%)
	Yes	Ramp XSlope (%)
	N/A	Flare Type LT
	N/A	Flare Slope LT (%)
	N/A	Flare Traversable I
	N/A	Landing Length (in
	N/A	Landing Width (in)
	N/A	Landing Slope (%)
	N/A	Landing X Slope (%
	N/A	Landing Curb? (Y/l
	N/A	Shared Landing?
	N/A	Gutter Ponding?
	N/A	Gutter Lip Ht (in)
	N/A	Painted X Walk1?
		X Walk 1 Direction
		X Walk 1 Width (in
		X Walk 1 Slope (%
		X Walk 1 X Slope (
	N/A	Ramp inside XWal
	N/A	Any Obstructions?
1600.00		Obstruction Type

Possible Solutions:				
Remove & Replace Entire Ramp.				
Surveyor Notes:				
N/A				
PROW/ADA:				
R304.2.2
