Access Compliance Report

Public Rights-of-Way

(Curb Ramps)

Intersection ID: 11329	Main Street: N_CLARKSON_ST	Cross Street: W_5TH_ST	Location: N
ADA ID: A6F754763837	Ramp Type: PerpDiag	Initial Pass/Fail: Pass	Overall Compliance: No
			Severity Score: 15.25

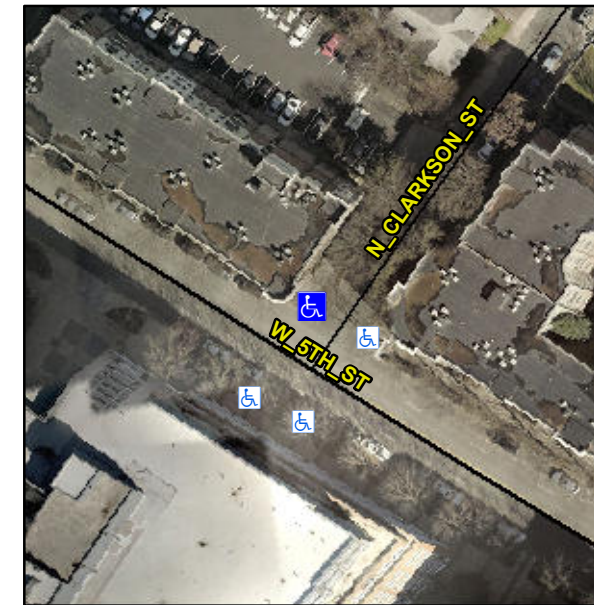
Compliance	Description	Data	Compliance	Description	Data
N/A	Ramp Length (in)	74.0	Yes	Ramp Slope (%)	5.5
Yes	Ramp Width (in)	48.5	No	Ramp XSlope (%)	3.1
N/A	Flare Type LT	Sloped	N/A	Flare Type RT	N/A
N/A	Flare Slope LT (%)	9.0	N/A	Flare Slope RT (%)	5.9
N/A	Flare Traversable LT?	Yes	N/A	Flare Traversable RT?	No
Yes	Landing Length (in)	100.0	Yes	DWS Provided?	Yes
Yes	Landing Width (in)	48.0	Yes	DWS Contrast?	Yes
Yes	Landing Slope (%)	0.7	Yes	DWS Length (in)	24.0
No	Landing X Slope (%)	2.3	Yes	DWS Full Width?	Yes
N/A	Landing Curb? (Y/N)	No	No	DWS Offset (in)	7.0
N/A	Shared Landing?	Yes			
Yes	Gutter Ponding?	No	Yes	Gutter Slope (%)	2.6
No	Gutter Lip Ht (in)	1.0	Yes	Gutter X Slope (%)	0.9
N/A	Painted X Walk1?	No	N/A	Painted X Walk2?	No
	X Walk 1 Direction	To SW		X Walk 2 Direction	To SE
N/A	X Walk 1 Width (in)	N/A	N/A	X Walk 2 Width (in)	N/A
	X Walk 1 Slope (%)	4.4		X Walk 2 Slope (%)	4.0
	X Walk 1 X Slope (%)	4.7		X Walk 2 X Slope (%)	1.4

N/A	Ramp inside XWalk1?	N/A	N/A	Ramp inside XWalk2?	N/A
	Road Slope (%)	1.4	N/A	Clear Space?	Yes
	Road X Slope (%)	5.3	N/A	Clear Space to XWalk (in)	N/A
Yes	Any Obstructions?	No	Yes	Storm Grate/Utility Hazard?	No
	Obstruction Type			Storm Grate/Utility Type	
		N/A			N/A
			Yes	Surface Condition? (G/P)	Good

Remove & Replace Curb Ramp With Two New Directional Ramps or Equivalent. Grind Gutter Lip.

R304.5.3, R305.2, R302.7.2
