# Access Compliance Report

## Public Rights-of-Way

### (Curb Ramps)

Intersection ID: 46027	Main Street: BOYSENBERRY_CT	Cross Street: PAULINE_LN	Location: NE
ADA ID: A7070C6F0E9C	Ramp Type: PerpDiag	Initial Pass/Fail: Fail	Overall Compliance: No
		Severity Score: 8.75

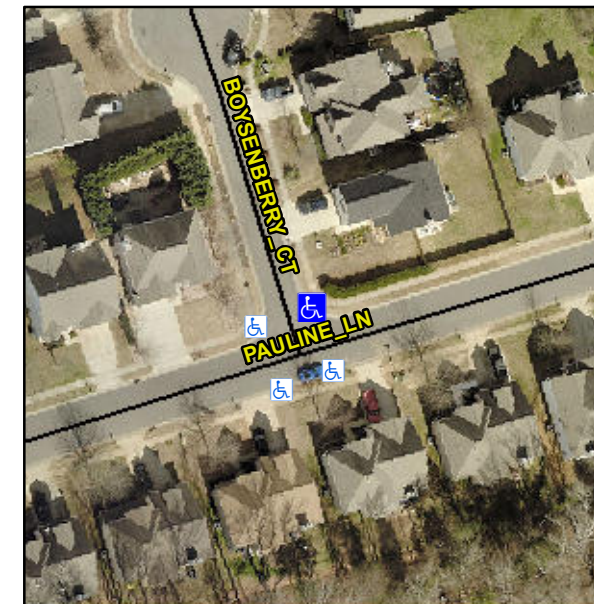
**Not Found, R304.5.1**

Compliance	Description	Data	Compliance	Description	Data
N/A	Ramp Length (in)	46.5	Yes	Ramp Slope (%)	6.0
No	Ramp Width (in)	38.0	Yes	Ramp XSlope (%)	1.8
N/A	Flare Type LT	N/A	N/A	Flare Type RT	N/A
N/A	Flare Slope LT (%)	N/A	N/A	Flare Slope RT (%)	N/A
N/A	Flare Traversable LT?	N/A	N/A	Flare Traversable RT?	N/A
N/A	Landing Length (in)	N/A	N/A	DWS Provided?	N/A
N/A	Landing Width (in)	N/A	N/A	DWS Contrast?	N/A
N/A	Landing Slope (%)	N/A	N/A	DWS Length (in)	N/A
N/A	Landing X Slope (%)	N/A	N/A	DWS Full Width?	N/A
N/A	Landing Curb? (Y/N)	N/A	N/A	DWS Offset (in)	N/A
N/A	Shared Landing?	N/A			
N/A	Gutter Ponding?	N/A	N/A	Gutter Slope (%)	N/A
N/A	Gutter Lip Ht (in)	N/A	N/A	Gutter X Slope (%)	N/A
N/A	Painted X Walk1?	No	N/A	Painted X Walk2?	No
	X Walk 1 Direction	To W		X Walk 2 Direction	To S
N/A	X Walk 1 Width (in)	N/A	N/A	X Walk 2 Width (in)	N/A
	X Walk 1 Slope (%)	6.8		X Walk 2 Slope (%)	2.2
	X Walk 1 X Slope (%)	2.1		X Walk 2 X Slope (%)	5.5

N/A	Ramp inside XWalk1?	N/A	N/A	Ramp inside XWalk2?	N/A
	Road Slope (%)	0.9	N/A	Clear Space?	N/A
	Road X Slope (%)	6.6	N/A	Clear Space to XWalk (in)	N/A
N/A	Any Obstructions?	N/A	N/A	Storm Grate/Utility Hazard?	N/A
	Obstruction Type			Storm Grate/Utility Type	
		N/A			N/A
			Yes	Surface Condition? (G/P)	Good

**Remove & Replace Curb Ramp With Two New Directional Ramps or Equivalent.**
