# Access Compliance Report

## Public Rights-of-Way

### (Curb Ramps)

Intersection ID: 48955	Main Street: ROYA_PL	Cross Street: DAVID_JENNINGS_AV	Location:	N
ADA ID: A70AD8CBCCA7	Ramp Type: Perp	Initial Pass/Fail: Fail	Overall Compliance: No	Severity Score: 10

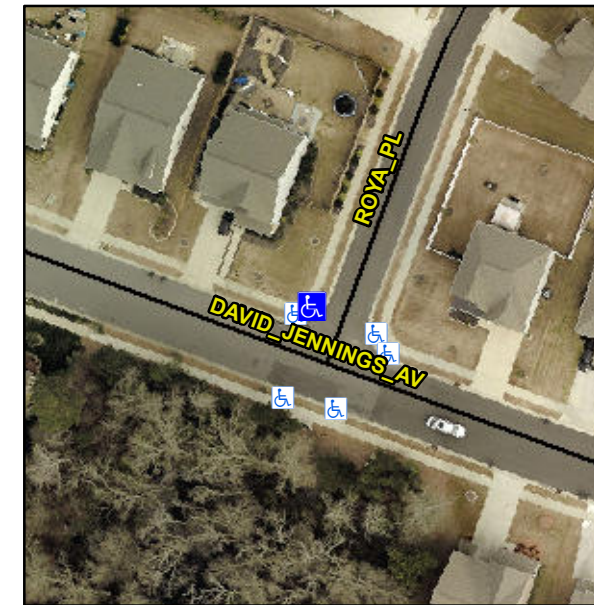
Compliance	Description	Data	Compliance	Description	Data
N/A	Ramp Length (in)	49.0	Yes	Ramp Slope (%)	5.3
No	Ramp Width (in)	47.0	No	Ramp XSlope (%)	2.5
N/A	Flare Type LT	N/A	N/A	Flare Type RT	N/A
N/A	Flare Slope LT (%)	N/A	N/A	Flare Slope RT (%)	N/A
N/A	Flare Traversable LT?	N/A	N/A	Flare Traversable RT?	N/A
N/A	Landing Length (in)	N/A	N/A	DWS Provided?	N/A
N/A	Landing Width (in)	N/A	N/A	DWS Contrast?	N/A
N/A	Landing Slope (%)	N/A	N/A	DWS Length (in)	N/A
N/A	Landing X Slope (%)	N/A	N/A	DWS Full Width?	N/A
N/A	Landing Curb? (Y/N)	N/A	N/A	DWS Offset (in)	N/A
N/A	Shared Landing?	N/A			
N/A	Gutter Ponding?	N/A	N/A	Gutter Slope (%)	N/A
N/A	Gutter Lip Ht (in)	1.0	N/A	Gutter X Slope (%)	N/A
N/A	Painted X Walk1?	No	N/A	Painted X Walk2?	N/A
	X Walk 1 Direction	To SE		X Walk 2 Direction	N/A
N/A	X Walk 1 Width (in)	N/A	N/A	X Walk 2 Width (in)	N/A
	X Walk 1 Slope (%)	0.3		X Walk 2 Slope (%)	N/A
	X Walk 1 X Slope (%)	3.0		X Walk 2 X Slope (%)	N/A

N/A	Ramp inside XWalk1?	N/A	N/A	Ramp inside XWalk2?	N/A
	Road Slope (%)	N/A	N/A	Clear Space?	N/A
	Road X Slope (%)	N/A	N/A	Clear Space to XWalk (in)	N/A
N/A	Any Obstructions?	N/A	N/A	Storm Grate/Utility Hazard?	N/A
	Obstruction Type			Storm Grate/Utility Type	
		N/A			N/A
			Yes	Surface Condition? (G/P)	Good

Possible Solutions:

**Remove & Replace Entire Ramp.**

**Not Found, R304.5.1, R304.5.3**
