# Access Compliance Report

## Public Rights-of-Way

### (Curb Ramps)

Intersection ID: N/A	Main Street: STYLE_LN	Cross Street: OUTLETS_BV	Location: NW
ADA ID: A714D2377873	Ramp Type: PerpDiag	Initial Pass/Fail: Fail	Overall Compliance: No
Severity Score: 58.75			
Codes/Mitigation Info/Possible Solution		Field Measurements/Component Compliance

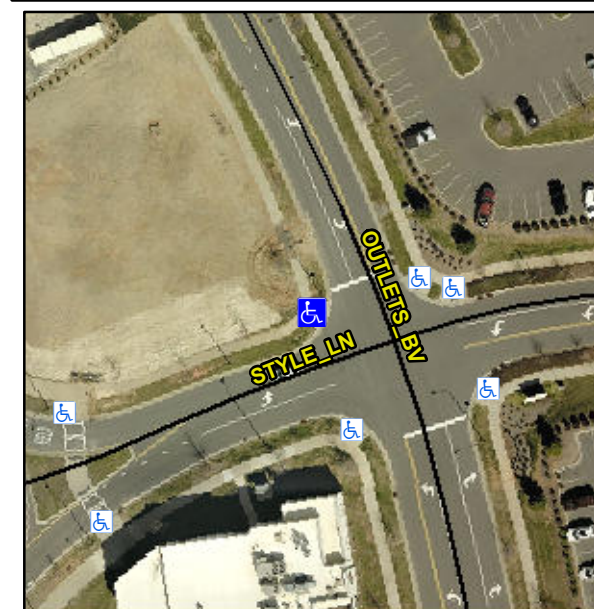
**Not Found, R304.5.1, R304.2.2, R304.5.3**

Compliance	Description	Data	Compliance	Description	Data
N/A	Ramp Length (in)	96.0	No	Ramp Slope (%)	12.1
No	Ramp Width (in)	42.0	No	Ramp XSlope (%)	8.7
N/A	Flare Type LT	N/A	N/A	Flare Type RT	N/A
N/A	Flare Slope LT (%)	N/A	N/A	Flare Slope RT (%)	N/A
N/A	Flare Traversable LT?	N/A	N/A	Flare Traversable RT?	N/A
N/A	Landing Length (in)	N/A	N/A	DWS Provided?	N/A
N/A	Landing Width (in)	N/A	N/A	DWS Contrast?	N/A
N/A	Landing Slope (%)	N/A	N/A	DWS Length (in)	N/A
N/A	Landing X Slope (%)	N/A	N/A	DWS Full Width?	N/A
N/A	Landing Curb? (Y/N)	N/A	N/A	DWS Offset (in)	N/A
N/A	Shared Landing?	N/A			
N/A	Gutter Ponding?	N/A	N/A	Gutter Slope (%)	N/A
N/A	Gutter Lip Ht (in)	N/A	N/A	Gutter X Slope (%)	N/A
N/A	Painted X Walk1?	No	N/A	Painted X Walk2?	No
	X Walk 1 Direction	To S		X Walk 2 Direction	To E
N/A	X Walk 1 Width (in)	N/A	N/A	X Walk 2 Width (in)	N/A
	X Walk 1 Slope (%)	0.7		X Walk 2 Slope (%)	5.5
	X Walk 1 X Slope (%)	3.7		X Walk 2 X Slope (%)	2.6

N/A	Ramp inside XWalk1?	N/A	N/A	Ramp inside XWalk2?	N/A
	Road Slope (%)	4.5	N/A	Clear Space?	N/A
	Road X Slope (%)	2.8	N/A	Clear Space to XWalk (in)	N/A
N/A	Any Obstructions?	N/A	N/A	Storm Grate/Utility Hazard?	N/A
	Obstruction Type			Storm Grate/Utility Type	
		N/A			N/A
		Yes		Surface Condition? (G/P)	Good

**Remove & Replace Curb Ramp With Two New Directional Ramps or Equivalent.**
