Intersection ID: 18066	Main Street: CHARMAPEG_AV	Cross Street: LYTTLETON_DR	Location:	NW
ADA ID: A7252EAD9D56	Ramp Type: PerpDiag	Initial Pass/Fail: Fail	Overall Compliance: No	Severity Score: 37.5

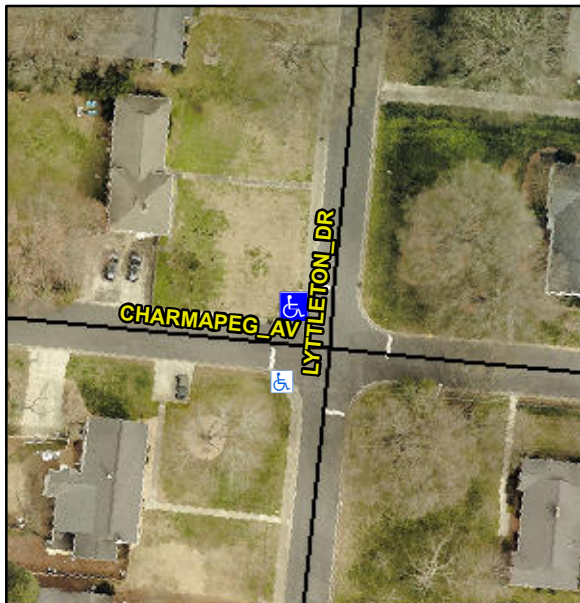
Possible Solutions:		Remove & Replace Curb Ramp With Two New Directional Ramps or Equivalent.			Compliance	Description	Data	Compliance	Description	Data
						N/A	Ramp Length (in)	49.0	No	Ramp Slope (%)	9.0
						Yes	Ramp Width (in)	48.0	No	Ramp XSlope (%)	7.6
						N/A	Flare Type LT	N/A	N/A	Flare Type RT	N/A
						N/A	Flare Slope LT (%)	N/A	N/A	Flare Slope RT (%)	N/A
						N/A	Flare Traversable LT?	N/A	N/A	Flare Traversable RT?	N/A
						N/A	Landing Length (in)	N/A	N/A	DWS Provided?	N/A
						N/A	Landing Width (in)	N/A	N/A	DWS Contrast?	N/A
						N/A	Landing Slope (%)	N/A	N/A	DWS Length (in)	N/A
						N/A	Landing X Slope (%)	N/A	N/A	DWS Full Width?	N/A
Surveyor Notes:		N/A			N/A	Landing Curb? (Y/N)	N/A	N/A	DWS Offset (in)	N/A	
PROW/ADA:		Not Found, R304.2.2, R304.5.3			N/A	Shared Landing?	N/A				
					N/A	Gutter Ponding?	N/A	N/A	Gutter Slope (%)	N/A

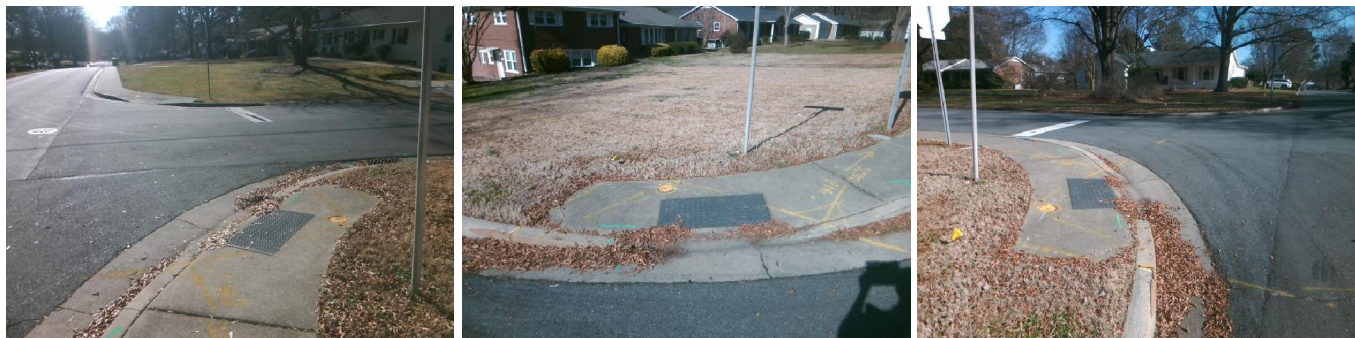
N/A	Gutter Lip Ht (in)	N/A	N/A	Gutter X Slope (%)	N/A	
					N/A	Painted X Walk1?	No	N/A	Painted X Walk2?	No	
						X Walk 1 Direction	To SW		X Walk 2 Direction	To SE	
					N/A	X Walk 1 Width (in)	N/A	N/A	X Walk 2 Width (in)	N/A	
						X Walk 1 Slope (%)	0.1		X Walk 2 Slope (%)	8.2	
						X Walk 1 X Slope (%)	7.8		X Walk 2 X Slope (%)	2.0	
Street 1 Name		CHARMAPEG AV			N/A	Ramp inside XWalk1?	N/A	N/A	Ramp inside XWalk2?	N/A	
Stop Condition-Street 2		StopSign				Road Slope (%)	5.9	N/A	Clear Space?	N/A	
Street 2 Name		LYTTLETON DR				Road X Slope (%)	7.6	N/A	Clear Space to XWalk (in)	N/A	
Stop Condition-Street 1		StopSign			N/A	Any Obstructions?	N/A	N/A	Storm Grate/Utility Hazard?	N/A	
						Obstruction Type			Storm Grate/Utility Type		
							N/A			N/A	
								Yes	Surface Condition? (G/P)	Good	
Total Cost:		\$ 3200.00
