# Access Compliance Report

## Public Rights-of-Way

### (Curb Ramps)

Intersection ID: 31878	Main Street: LANGDEN_GATE_DR	Cross Street: WILLIAMS_GLENN_RD	Location: NW
ADA ID: A732DB07122F	Ramp Type: PerpDiag	Initial Pass/Fail: Fail	Overall Compliance: No
Severity Score: 22.5			
Codes/Mitigation Info/Possible Solution		Field Measurements/Component Compliance

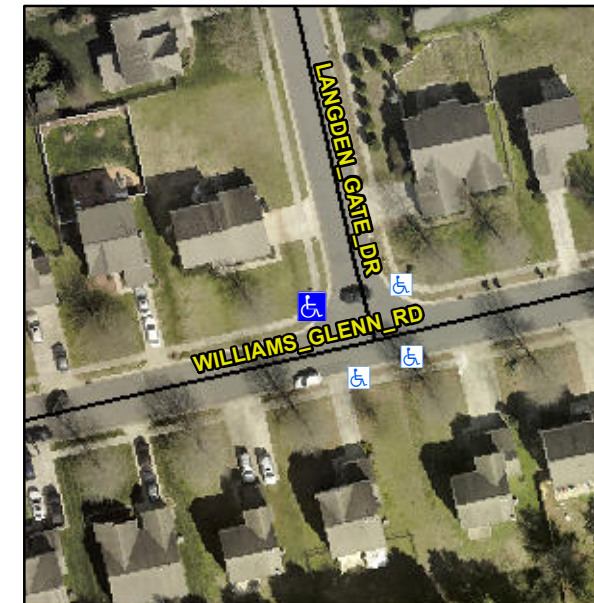
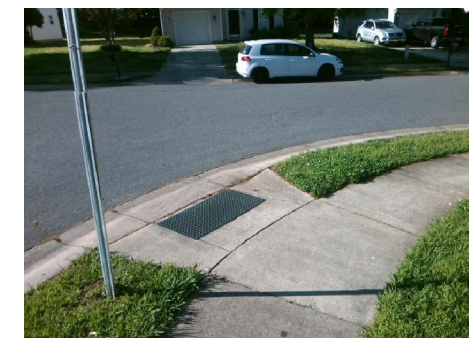
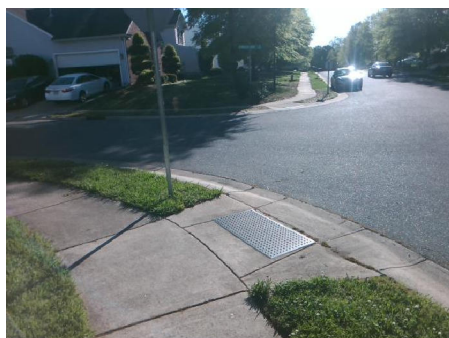
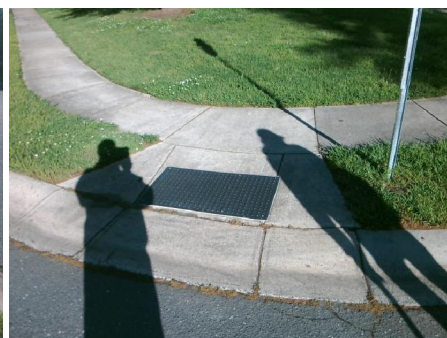
Compliance	Description	Data	Compliance	Description	Data
N/A	Ramp Length (in)	44.0	No	Ramp Slope (%)	9.2
No	Ramp Width (in)	45.0	No	Ramp XSlope (%)	3.5
N/A	Flare Type LT	N/A	N/A	Flare Type RT	N/A
N/A	Flare Slope LT (%)	N/A	N/A	Flare Slope RT (%)	N/A
N/A	Flare Traversable LT?	N/A	N/A	Flare Traversable RT?	N/A
N/A	Landing Length (in)	N/A	N/A	DWS Provided?	N/A
N/A	Landing Width (in)	N/A	N/A	DWS Contrast?	N/A
N/A	Landing Slope (%)	N/A	N/A	DWS Length (in)	N/A
N/A	Landing X Slope (%)	N/A	N/A	DWS Full Width?	N/A
N/A	Landing Curb? (Y/N)	N/A	N/A	DWS Offset (in)	N/A
N/A	Shared Landing?	N/A			
N/A	Gutter Ponding?	N/A	N/A	Gutter Slope (%)	N/A
N/A	Gutter Lip Ht (in)	N/A	N/A	Gutter X Slope (%)	N/A
N/A	Painted X Walk1?	No	N/A	Painted X Walk2?	No
	X Walk 1 Direction	To S		X Walk 2 Direction	To E
N/A	X Walk 1 Width (in)	N/A	N/A	X Walk 2 Width (in)	N/A
	X Walk 1 Slope (%)	1.5		X Walk 2 Slope (%)	3.5
	X Walk 1 X Slope (%)	4.5		X Walk 2 X Slope (%)	1.2

N/A	Ramp inside XWalk1?	N/A	N/A	Ramp inside XWalk2?	N/A
	Road Slope (%)	3.4	N/A	Clear Space?	N/A
	Road X Slope (%)	3.3	N/A	Clear Space to XWalk (in)	N/A
N/A	Any Obstructions?	N/A	N/A	Storm Grate/Utility Hazard?	N/A
	Obstruction Type			Storm Grate/Utility Type	
		N/A			N/A
			Yes	Surface Condition? (G/P)	Good

**Remove & Replace Curb Ramp With Two New Directional Ramps or Equivalent.**

**R304.5.1, R304.2.2, R304.5.3**
